The evaluation of damage mechanism of unreinforced masonry buildings after Van (2011) and Elazig (2010) Earthquakes

D Güney¹, E Aydın², B Öztürk³

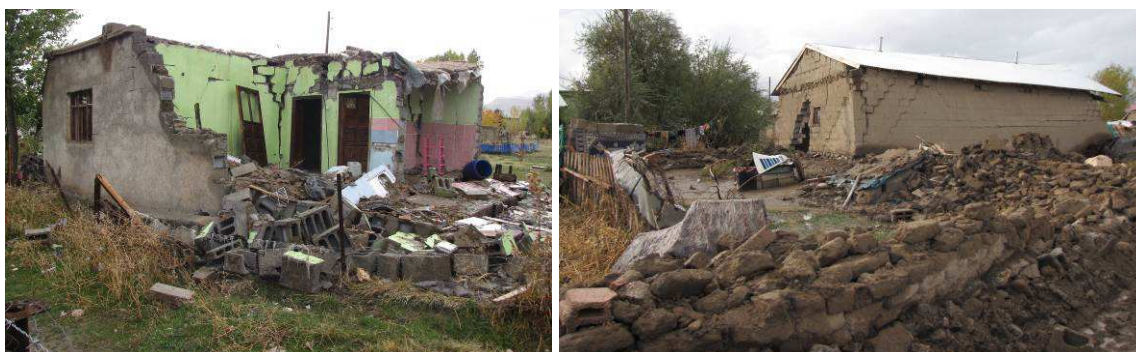
The use of mud mortar for adobe and briquette blocks cause low lateral force resistance. Mud as mortar has low strength and has poor bonding characteristics. As a result of this, masonry buildings performed very poor lateral resistance to seismic forces and damaged or collapsed easily as shown in Figure 12.

Figure 12. Improper mortar use such as mud

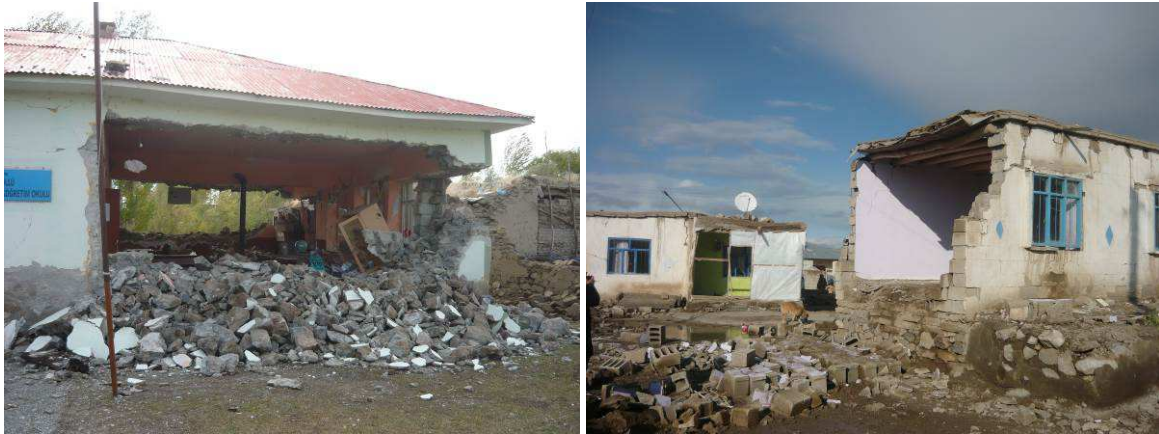
In addition to previous reasons, construction method is also against basic structural design criteria. Wall-to-wall and wall-to-floor connections are very poor. Therefore infill walls collapsed easily during the earthquake as shown in Figure 13.

Figure 13. Poor wall-to-wall and wall-to-floor connections

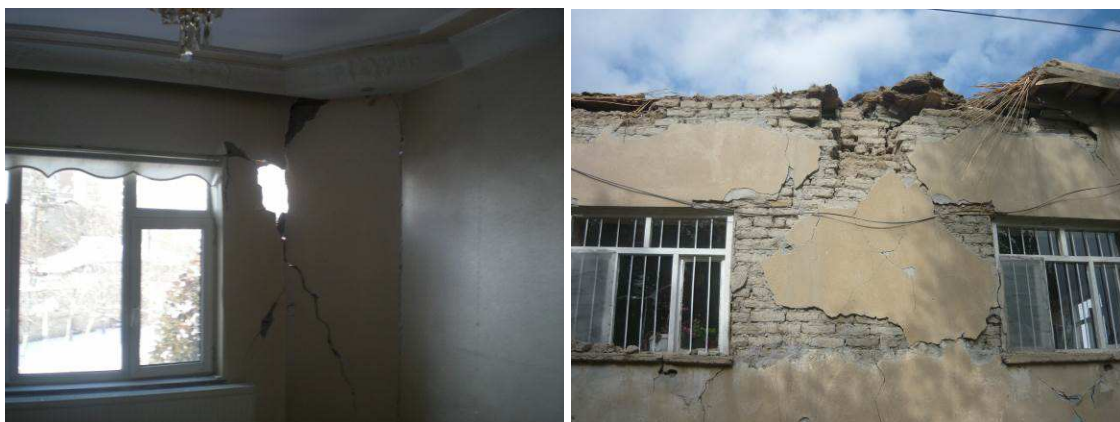
Improper placement of door and window openings in walls caused serious damages in the region, which creates vulnerable and weak zones in the structure as shown in Figure 15.

Figure 15. Improper placement of door and window openings
