THE BEHAVIOUR OF STRUCTURES BUILT ON ACTIVE FAULT ZONES : EXAMPLES FROM THE RECENT EARTHQUAKES OF TURKEY

Reşat ULUSAY¹, Ömer AYDAN² and Masanori HAMADA³

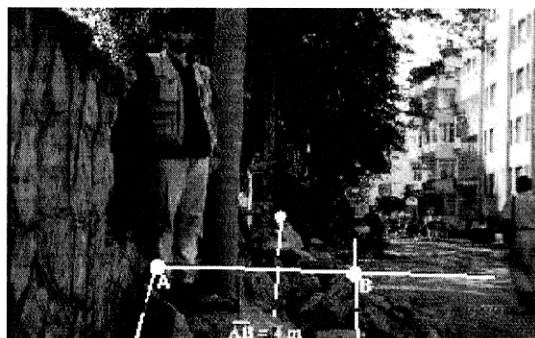
From the surveys of offset fence lines, roads and tree lines, the maximum offset along the surface rupture was measured about 4.5-5 m (Fig.3). General trend of the surface rupture has an orientation of NE-SW in the east between Gölyaka and Akyazi and then it appears with a general trend of E-W in the western part of the earthquake region. Width of the primary surface rupture traces varied from 5 to 20 m with little or no secondary deformation. However, broad zones of primary and secondary deformation up to 200 m wide were evident. The fault rupture produced typical examples of strike-slip offset, including well-formed moletracks, left-stepping en-echelon fault traces in various scales, uplift of pressure ridges and subsidence (Fig.4). Furthermore, the observations of striations on the existing fault rupture near Arifiye (Adapazarı) and Tepetarla (between Adapazarı and Kocaeli) imply that the vertical component of the fault motion has a normal fault sense with vertical offsets of 10–20 cm in these parts of the fault segment. This may be a further evidence of trans-tensional nature of the western part of the North Anatolian Fault.

Fig.3 A typical view from the right lateral offset during Kocaeli earthquake (western wall of the Naval Command Center in Gölcük / slip: 4–5 m)

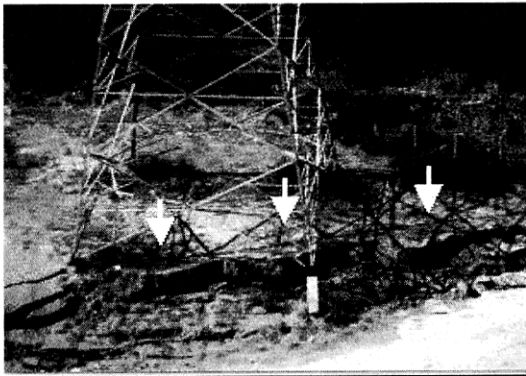
with any other earthquake break. This fault caused rotation of a pylon of a power line (Fig.6) near the Ford automobile factory construction site about 10 degrees and global subsidence of the basin with local submergence of the coastline and inundation of the

Fig.6 The fault with a normal component which caused rotation of a pylon of power line at the south of Ford automobile factory construction site.

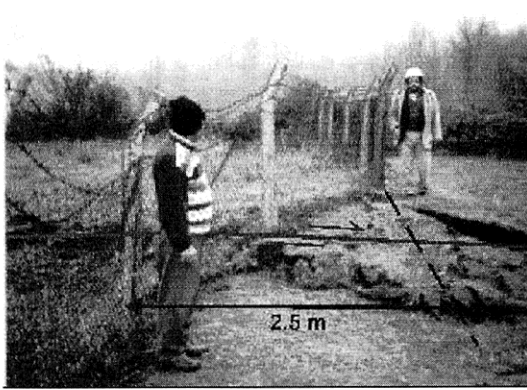
The maximum lateral offset is about 5 m. As seen from Fig.9, the amount of right-lateral offsets, clearly observed on roads, fences and tree lines (Fig.10), in-

Fig.10 A typical right lateral offsets from the surface fault rupture resulted from the 1999 Düzce earthquake.

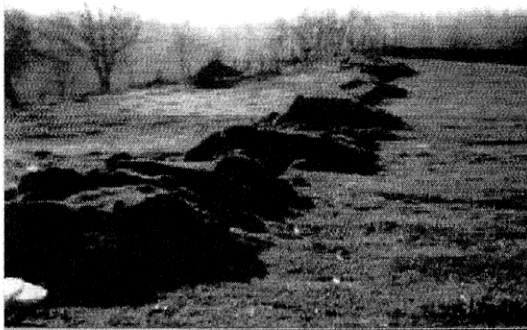
Fig.11 A typical view from the surface rupture and pressure ridges at the eastern part of Cinarli village (view from east to west).

E-W. Due to left stepping observed at some locations, pressure ridges were evident (**Fig.11**). In this zone, in addition to Riedel fractures crossing the main rupture surface with angles between 25° and 60° , en-echelon fractures were also well developed. The direction of fault scarps coincides almost with those obtained from the fault plane solutions. The surface rupture seems not to follow the depicted fault segment that passes through the boundary between the alluvial sequence and rock units at the southern edge of Düzce Plain. It should be remembered that such traces of rupture observed along the south of the Düzce plain are just the products of flowering phenomenon during the motion of strike-slip faults as a result of reduction of vertical stress near the ground surface.

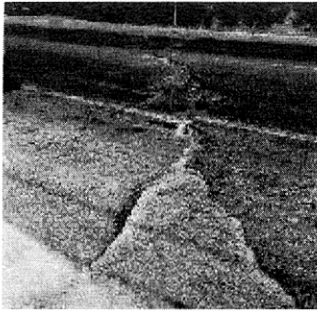
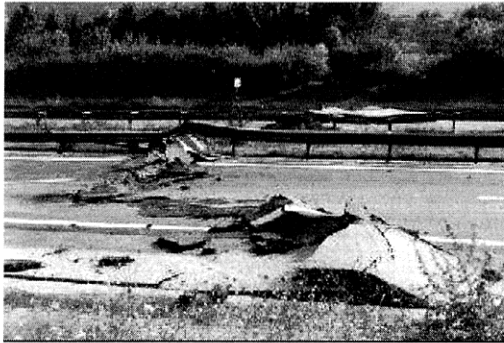
The E-5 (D-100) highway and TEM, connecting Ankara to Istanbul, also pass through the region affected by the Düzce earthquake. The fault break observed in this earthquake crossed the E-5 highway in Kaynasli town between Bolu and Düzce cities (**Fig.13a**). In addition to these, several country roads were crossed by the fault break (**Fig.13b**) and easily levelled with the dirt available on the site. The surface of the roadway directly built on existing ground surface was buckled since the maximum compres-

Fig.12 (a) Damaged D-100 highway, and (b) buckling of roadway surfacing on the motorway between Adapazari and Kocaeli.

From these examples it is clear that some damage to roadways could not be prevented where the relative movement of the ground occur due to faulting and non-elevation of roadways in fault zones is a key element to deal with the negative effects of faulting on roadways. There is a very important engineering decision, that is, the highways should be directly built over the existing ground surface in active fault zones.

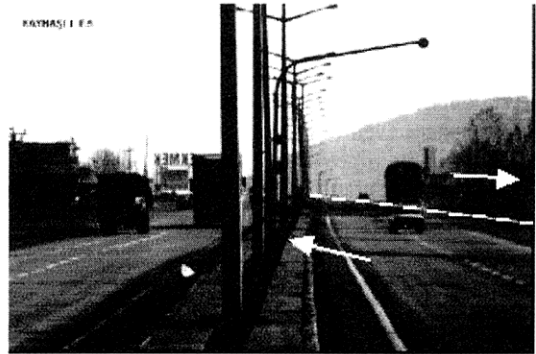
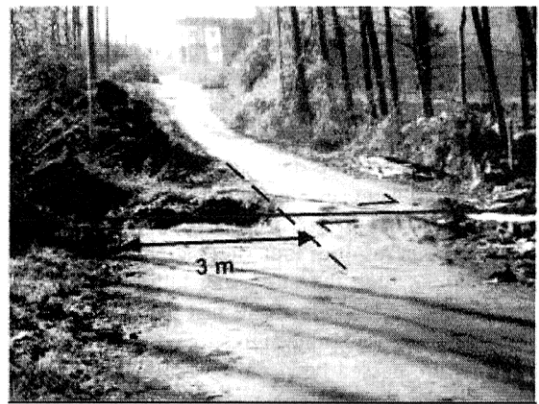
Fig.13 (a) Damaged and repaired location of the E-5 highway in Kaynasli and (b) a displaced local road at Kaynasli.

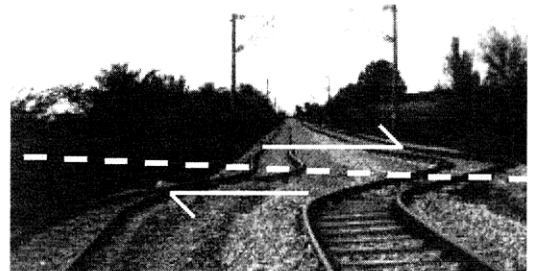
Fig.14 Buckled railway near Tepetarla station.

rail with an angle of 60°. The right lateral offset was 2.5 m near this station. This direction is almost parallel to the maximum compression of the ground due to faulting and an approximately 200 m section of the railways was damaged. The ground was also heavily deformed by faulting for a length of 700 m resulted near the Kurtköy (close to Arifiye). The railways, however, were operational within three days after the earthquake by replacing buckled rails and damaged traverses, and the railways were completely repaired together with the correction of displaced alignment in 20 days after the earthquake, so that trains began to

Although the damage to the railways could not also be prevented, even they are directly built on the existing ground surface where the railways must pass through an active fault zone, the recovery of railways is very quick.

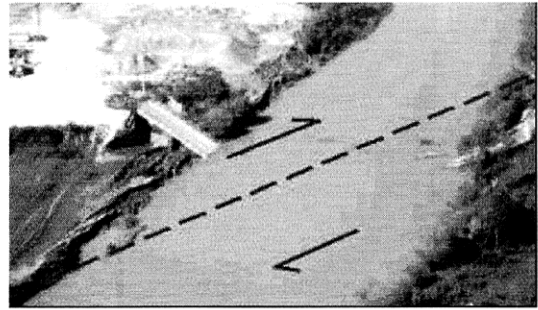
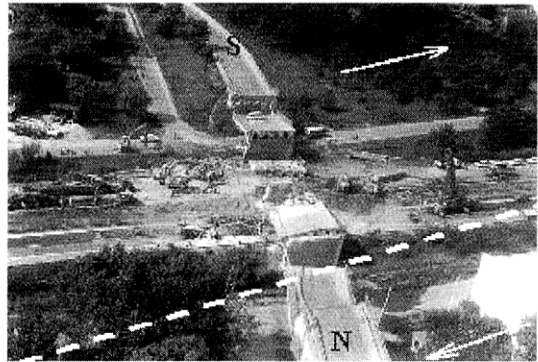
Bridges and viaducts are elevated structures. Since roadways and railways were not elevated structures, no viaducts existed in the region of the fault breaks resulted from the Kocaeli earthquake. The bridges of highways and railways over Sakarya River were intact and no direct faulting event occurred at these localities. However, the YSE bridge spanning over Sakarya River for a service road collapsed as a result of relative motion due to faulting between its abutments (**Fig.15a**). Along the damaged section of the motorway, there were several overpass bridges. Among them, a four span overpass bridge at Arifiye junction collapsed as a result of faulting (**Fig.15b**). The girders collapsed onto the motorway killing more than 10 people in a bus who were just happened underneath the overpass bridge at the time of collapse. The fault rupture passed between the northern abutment and the adjacent pier. The overpass was designed as a simply supported structure according to the modified AASHTO standards and girders had elastometric bearings. However, the girders were connected to each other through pre-stressed cables. The angle between the motorway and the strike of the earthquake fault was approximately 15° , while the angle between the axis of the overpass bridge and the strike of the fault was 65° . The measurements of the relative displacement in the vicinity of the fault ranges between 330 and 450 cm. Therefore, an average value of 390 cm could be assumed for the relative displacement between the pier and the abutment of the bridge. The girders of the bridge rotated and pulled so that the fall of the girders between the north abutment and the adjacent pier could not be prevented. However, the collapse of the other girders of the remaining part of the bridge might have been prevented if the girders were not connected to each other through the pre-stressed cables.

Fig.15 (a) A view from a collapsed bridge on Sakarya River at 5 km of SE of Adapazari due to faulting (view from south to north), and (b) an aerial view from the collapsed overpass bridge onto the motorway near Arifiye.

The examples mentioned above indicated that it is not desirable to elevate the roadways in fault zones where permanent deformation of the ground may take place during earthquakes. If they have to be elevated for some important reasons, such as floods or landslides, the limitation of roadway inclination, etc., as being in the case of viaducts in Asarsuyu valley, it seems better that the girders should be designed as redundant structures, and simply supported structures must be avoided as much as possible. Furthermore, T-type piers should be generally avoided as this type piers result in top-heavy situations.

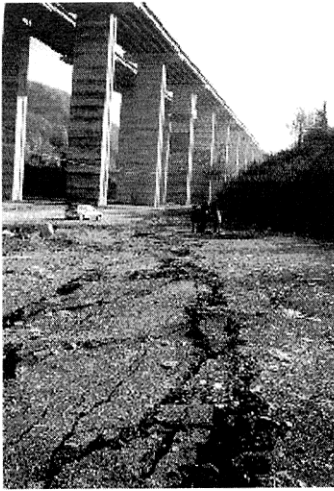
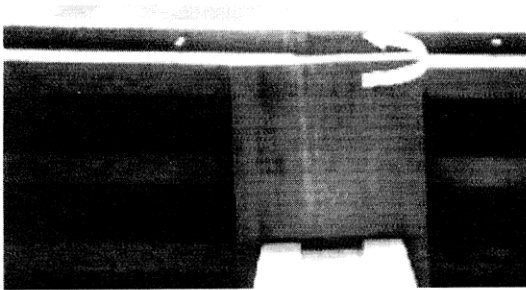
diameter of 180 cm. The elevated section is divided into large segments, namely East viaducts and West viaducts. Although the viaducts exhibited a well performance in the Kocaeli earthquake, the fault break passed through the elevated section of the TEM in Asarsuyu valley at an angle of 20° – 30° and caused the rotation and tilting of some of piers during the Düzce earthquake (**Fig.16**). As a result of that, the simply supported girders of the viaducts were displaced from their supports. Although no girder was fallen off and piers performed very well during the earthquake, some of the girder were very close to fall.

Fig.16 (a) The surface rupture of the Düzce earthquake appearing below the viaducts of the motorway, and (b) a view from displaced girders of the viaducts.

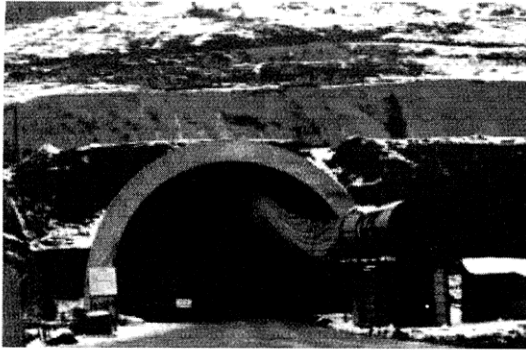
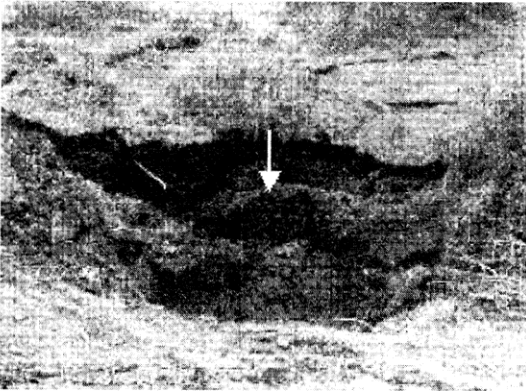
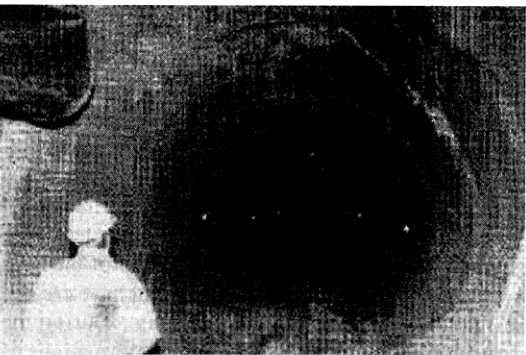
Fig.17 (a) View from the Elmalik portal of the Bolu Tunnels, (b) surface crater above the collapsed main tunnel on the Elmalik side⁹⁾, and (c) damages to pilot tunnels⁹⁾.

After a certain period of time, it was reported that a collapse occurred in an unfinished portion of the tunnel in the fault gauge zone on the Elmalik side where the major difficulties had previously been experienced⁹⁾. The collapse on the Elmalik side occurred about 50 m beyond the end of the completed inner lining section. Cracks and craters could be observed on the surface (**Fig.17 b**), although the overburden is more than 50 m at this location. This section is located at the transition from fairly good ground into a major fault zone. Damage can be observed at the inner side drift shotcrete structure. The 30 cm thick shotcrete shell was fractured in the invert and the shoulders (**Fig.17c**). The causes for this behaviour still have to be determined. It is also noted that accelerations of 0.6 to 0.8 g were measured at the stations in the vicinity of the site, far in excess of the 0.4 g design with the preliminary assessments arisen from the authors about the possible damage to the tunnel.

As understood from these examples, it is difficult to prevent the rupturing of tunnel linings at locations where the fault cause relative movements. Nevertheless, this type of damage is quite localised and it does not cause any danger to the overall stability of tunnels. Therefore, the current seismic design concepts for tunnels can be safely used and design should also be based on dynamic numerical calculations.

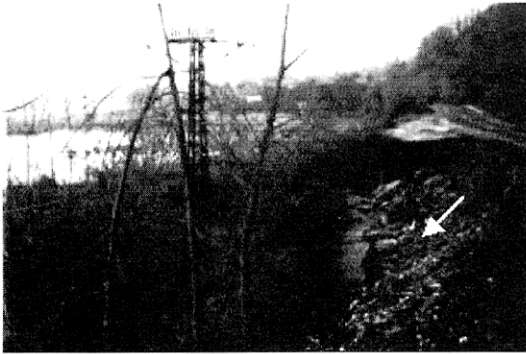
During the Düzce earthquake, the fault break induced damage to a minor energy transmission line occurred near Cevizli village as shown in **Fig. 18a**. The roadway embankment failure induced by the fault break nearby Efteni Lake caused the steel pylons sank to the lake and electricity cables were subsequently cut off.

Fig.18 (a) Damaged to a minor energy transmission line due to fault break induced embankment failure of a roadway on the shore of Efteni Lake, and (b) ruptured plastic pipe in Findikli village (Düzce earthquake).

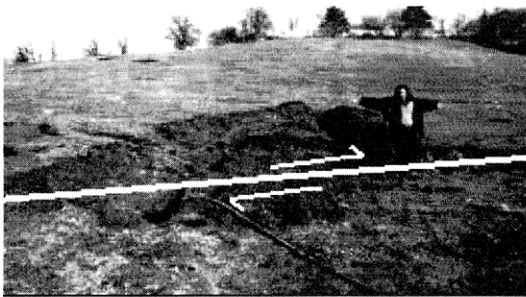
(b)

No damage to the wells, pipes and pumps of the water supply systems during the Düzce earthquake was reported. Nevertheless, it is reported that the water supply system of Düzce city was heavily damaged as a result of breaks at pipe joints due to ground shaking and probably lateral spreading. The damage to the water supply system of Kaynasli town was quite heavy since the water pipes were damaged by either buckling or breaking as a result of ground shaking and faulting. The damage to asbestos or plastic pipes and was quite heavy (**Fig.18b**).

Ground failure, rather than ground shaking, is the principal cause of damage to tubular structures. The damage to tubular structures is generally difficult to prevent during faulting. The brittle sewer pipes tend to fail under much lower strains than water lines, so damage to sewer lines is considerable more extensive. Such systems are checked systematically through water flow states at manholes in cities, towns and vil-

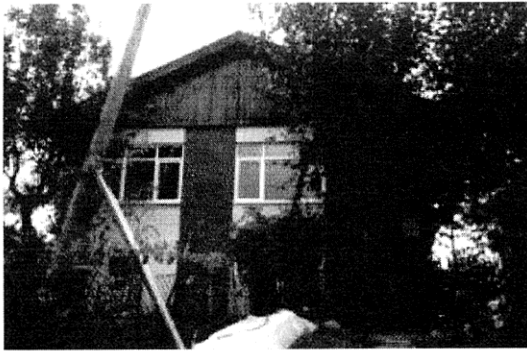
The first example from the Kocaeli earthquake is a two-story reinforced concrete house with a raft foundation in Tepetarla village. The fault passed just underneath the foundation of the southern side of the building (**Fig.19a**). The relative displacement of the fault break was about 200 cm. Since 70% of the foundation of the building was on the stationary northern side of the fault and the southern side of the fault had a very small amount normal component, no damage to this building was observed. In other words, this implies that if the fault just slides beneath a structure with a raft foundation in the case of strike-slip faulting, no damage could be caused to the structure, provided that the structure is strong enough against shaking.

Fig.19 (a) The behaviour of a two-storey reinforced building at Tepetarla; (b) the collapse of apartment block at Kullar, and (c) rotated buildings due to strike-slip faulting in Gölcük (Kocaeli earthquake).

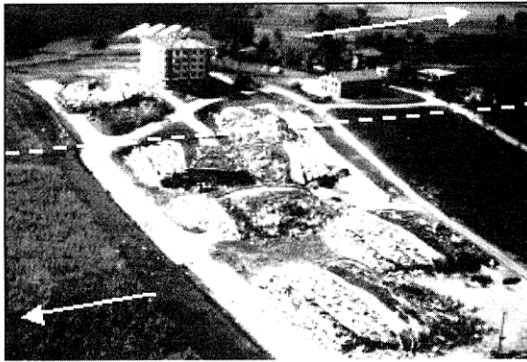
(b)

A very peculiar behaviour of an apartment complex consisting of 8 five-story apartment blocks was observed in Kullar village (**Fig.19b**). Seven apartment blocks failed in a pancake mode while one apartment block remained self-standing. One of the failed apartment blocks just crossed by the fault break that has a relative horizontal displacement of 240 cm and 20–25 cm vertical throw (north side down). The ground surface was sloping to north. One of two apartment blocks on the southern side was damaged while the other one collapsed towards east in a pancake mode in accordance with the movement of its foundation. The 5 blocks on the northern side were completely collapsed in a pancake mode towards west in accordance with the direction of shaking. Except the apartment block over the fault break, the failure of 5 blocks on the northern side of the fault break may be con-

sidered to be purely due to shaking. Although the intensity of shaking on the southern side of the fault break should be the same, the damaged self-standing apartment block should deserve some special consideration. The simplest explanation may be just a slight variation of the ground condition if the apartment blocks are assumed to be structurally identical. Whatever the reason is, it is of great interest that the most vulnerable buildings may also survive within a distance of 5 to 6 m to the fault break during the inland earthquakes.

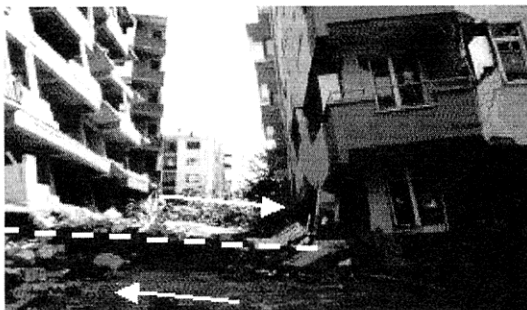
(c)

Third example from the Kocaeli earthquake is concerned with the behaviour of apartment buildings beneath which a fault break with a relative horizontal displacement of 450 cm and 50 cm vertical throw passed in Yüzbasilar district of Gölcük town. As seen from **Fig.19c**, the apartment buildings were severely damaged by torsion, but did not totally collapse due to the close proximity of their foundation resulting in some lateral restrains during the interaction of their foundations and the fault break.

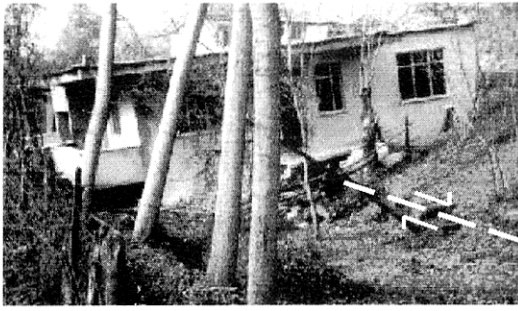
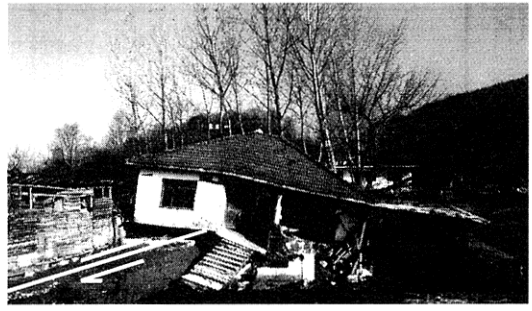
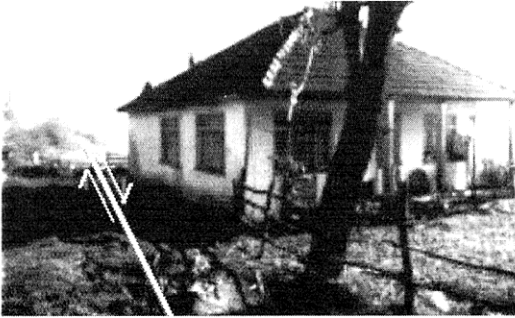
Fig.20 (a) Tilted and rotated one-story reinforced concrete building in Findikli, (b) one-story himis building in Çakirbrahim village, (c) a brick masonry house in Findikli village, and (d) a totally collapsed 5-story reinforced concrete building in Kaynasli (Düzce earthquake).

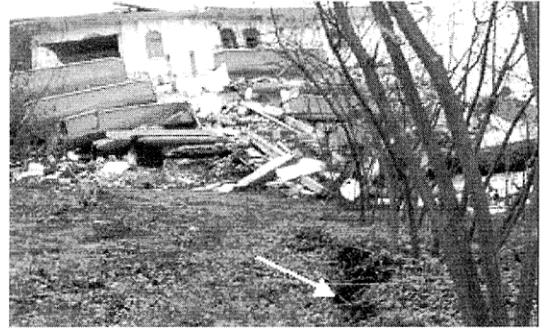
(d)

The reinforced concrete buildings with 4 stories or more on the alluvial plain collapsed. **Fig.20d** shows a totally collapsed 5-story reinforced concrete building in Kaynasli, beneath that the fault break passed. Of course, one may easily think of the fault break as primary culprit for the collapse of this building. Considering other totally collapsed similar type buildings, which were not directly crossed by the fault, it should be plausible to put the blame directly onto the fault break.

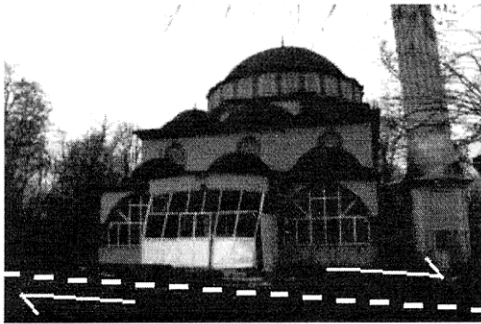
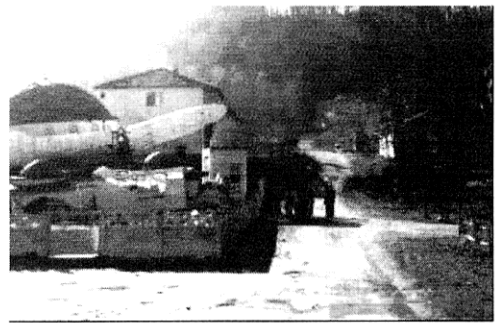
Fig.21 (a) Partially damaged mosque in Dariyeri Hasanbey village due to fault break passing beneath the left corner of the main compound, and (b) a collapsed mosque in Kaynasli due to fault break passing beneath the main compound (Düzce earthquake).

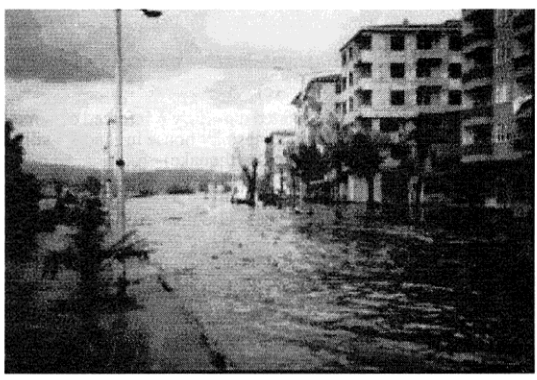
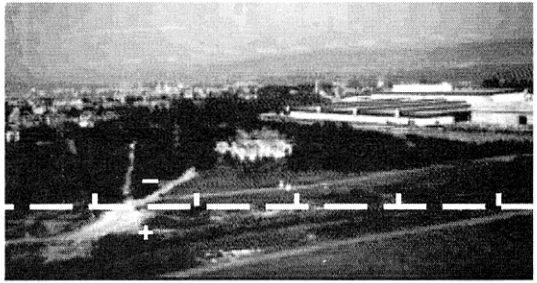
the Izmit Gulf during the 1999 Kocaeli earthquake. This ground failure was typically observed between Kavakli district of Gölcük town (Fig.23 a) and Seymen at its east. As previously discussed in 3.(1), the ground subsidence took place as a result of secondary normal faulting associated with the main lateral strike-slip event (see Fig.5). The land on the overhanging block of the fault subsided with a gradual tilt towards the sea with the northern tip submerged into the sea. In other words, a huge land has moved as a whole towards the sea with lower relief. A large industrial plant under construction for Ford Otosan was on the overhanging wall of the fault. It was undamaged except where ground settlement and trace of the normal fault with a vertical throw of 240 cm intersected one corner of the 50.000 m² building (Fig.23b). At this location the building (steel roof trusses on concrete columns with metal cladding) experienced settlements that pulled the columns over several tens of centimetres. Particularly at Kavakli, fine sand was ejected as a result of liquefaction (see Fig.23a). However, the subsidence was mainly associated with the ground settlement due to normal faulting and partly lateral spreading induced by liquefaction.

Fig.23 (a) Submerged Kavakli district of Gölcük town due to normal fault induced ground subsidence, and (b) a view of Ford-Otosan factory with the normal fault scarp.

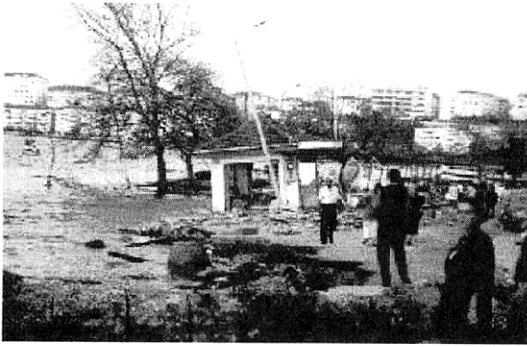
Fig.24 Coastal land chopped away into the sea due to submarine landslide at Degirmendere during 1999 Kocaeli earthquake.
