**A GENERAL EVALUATION OF THE PERFORMANCE  
OF ROADHEADERS USED IN COAL MINES**

**Behnaz HALLAJI DİBAVAR**

Submitted to  
Graduate School of Science and Engineering of Hacettepe University as a Partial  
Fulfillment to the Requirements for the Award of the Degree of Doctor of Philosophy in  
Mining Engineering.

2023

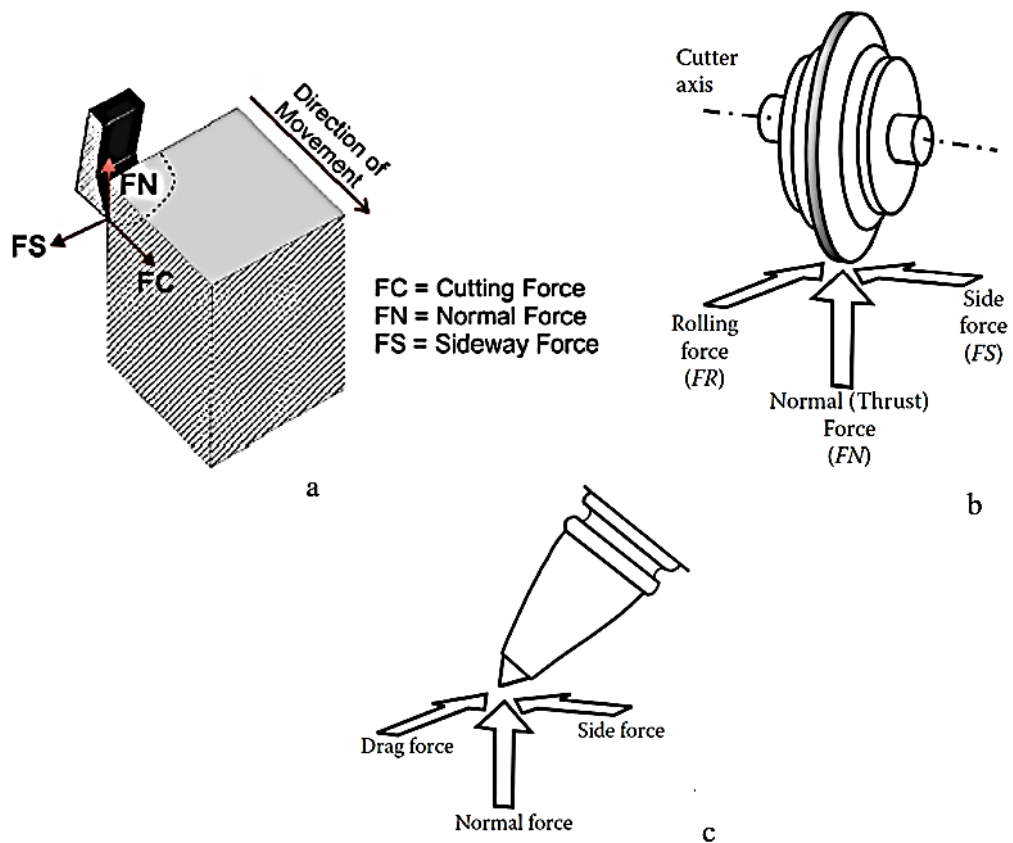
Figure 2.1. Forces acting on: a) simple chisel cutter, b) disk cutter, c) conical cutter during excavation (Yasar and Yilmaz, 2018; Bilgin, Copur and Balci, 2013).

The rock properties and cutter configurations are determining parameters in the failure mode of the rock (Copur et al., 2003). For instance, sharp cutters cut the rock in pure shearing mode, and the amount of small particles generated during the excavation decreases. Since normal force is the determinative parameter in penetration depth, cutting efficiency is specified by the normal force for chisel and point attack cutters. Additionally, the rolling/drag/cutting force is in direct relation with the torque capacity of the mechanical excavator, while normal force is correlated to thrust force.

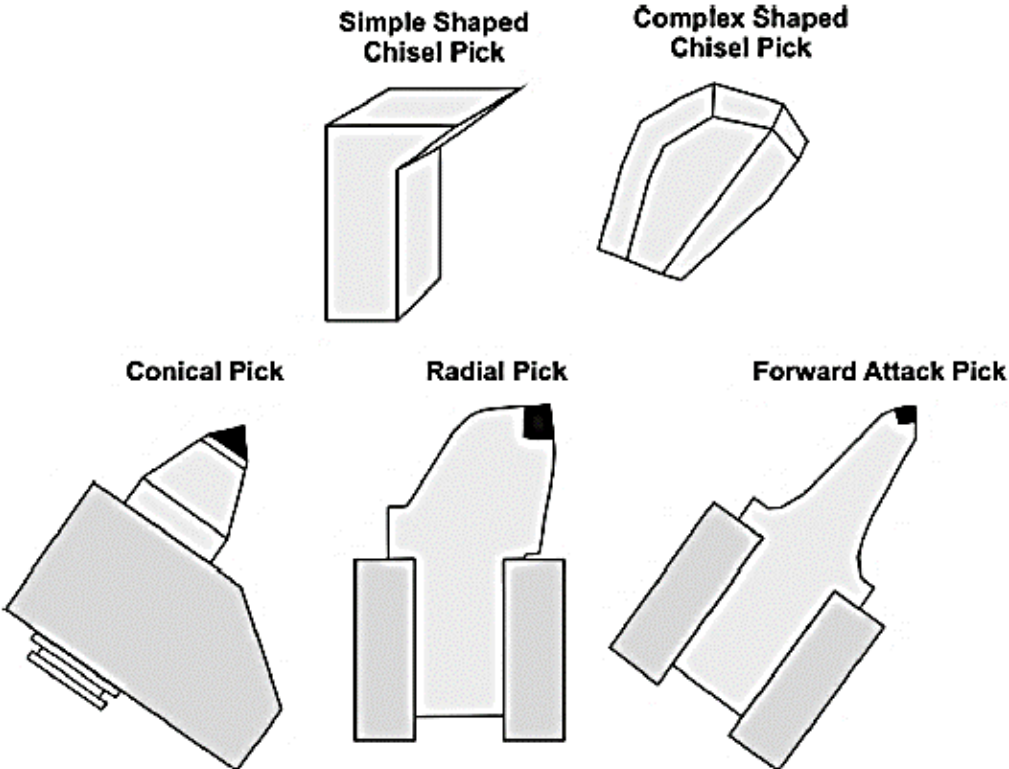
Figure 2.2. Various types of drag pick (Yasar and Yilmaz, 2018).

Different types of drag picks are illustrated in Figure 2.2. These cutters, made of tungsten carbide and cobalt, are preferred due to their economical aspect and ability to excavate effectively under certain conditions. Drag picks are generally used to excavate coal and soft formations. Chisel (wedge) cutters are suitable for soft formations, whereas point attack (conical) picks are suitable for harder and more abrasive formations. Radial picks are less effective than other cutters, and they become significantly less effective as they get blunt. Hence, point attack picks are typically chosen over radial picks (Bilgin, Copur and Balci 2013). Additionally, point attack picks are self-sharpening since they can rotate freely in their holders (Hartman et al., 1992), so they become less blunt over time and have a longer life time. Point attack picks are employed in machines such as coal ploughs, roadheaders, continuous miners, and shearers. The forward-leaning shape of chisel and point attack picks increases their durability during the cutting. The moving direction of

drag picks during the excavation is parallel to the cutting face, and the cutting action is almost similar for all of them. The moving direction of drag picks cause them to cut off a large piece of rock when the cutter is first pushed into the rock surface, creating a crushed zone beneath the cutter tip. This phenomenon coincides with chip generation stemmed from crack propagation in the crushed zone. However, the major part of the energy required for excavation by drag picks is consumed to cut the large rock piece in the beginning stage, not for producing the secondary small crushed particles (Yasar and Yilmaz, 2018).

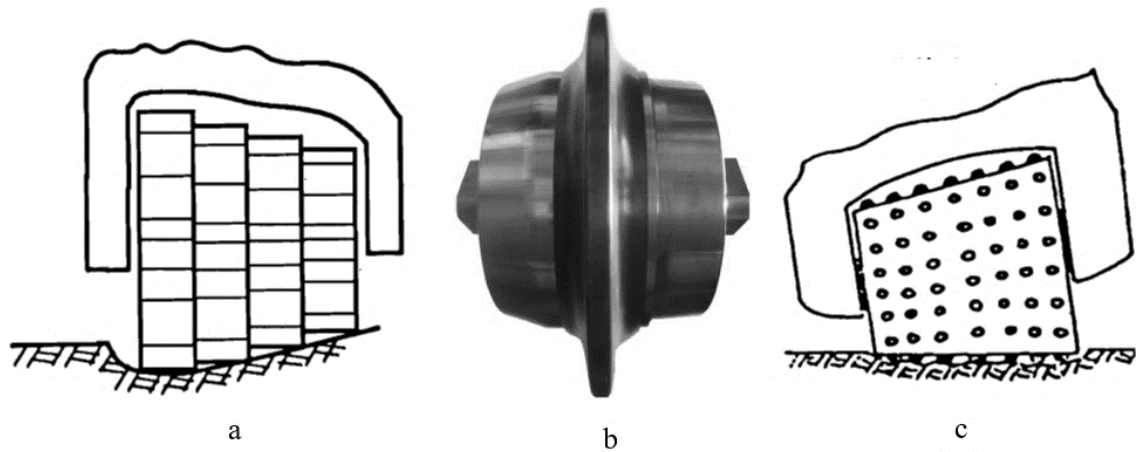
Figure 2.3. a) Multiple disk cutter b) single V-shaped disk cutter c) button cutter (Bilgin, Copur and Balci, 2013).

Roller cutters are used in Tunnel Boring Machines (TBMs) and raise boring machines. Disc cutters are the most common type of roller cutters. They are used for excavating medium-strength to very hard and abrasive rocks. Various types of disk cutters are shown in Figure 2.3. Simple disk cutters are generally employed in TBMs, while the multi-row disk cutters are used in raise boring machines (Hartman et al., 1992).

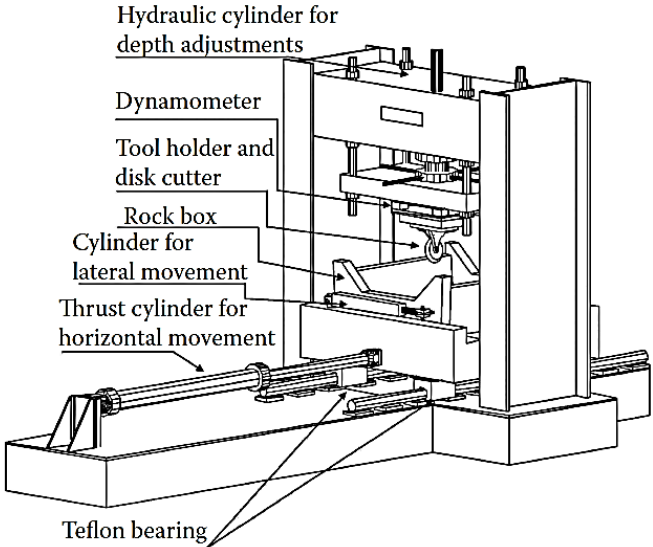
Figure 2.4. Schematic illustration of full-scale cutting machine (Çopur et al. 2001).

Figure 2.4 depicts a view of a full-scale linear rock cutting machine. In this test, a rock block of a maximum  $60 \times 80 \times 100 \text{ cm}^3$  dimension is cast in concrete in a heavy box and is subjected to cutting with a real-life cutter. The sample could be adjusted to different angles with respect to the present discontinuities, joint sets, or bedding planes to reflect the real condition of the investigated formation. The cutting speed and the cut depth and spacing are adjusted prior to cutting, and the process is repeated at various intervals to incorporate the effect of multiple cutters. The cutting, normal, and side forces imposed on the cutters during the cutting process are measured by a dynamometer. The collected data from the dynamometer is used to identify the SE as follows:

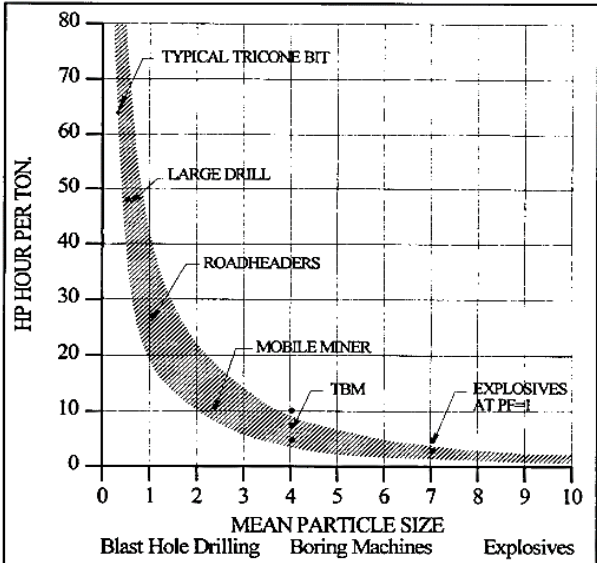
Figure 2.5. Specific Energy in relation to the particle size of muck (Rostami, Ozdemir and Neil, 1995).

decreases, the power requirements increase, as represented in Figure 2.5. In other words, higher SE is needed to generate smaller rock pieces, and less SE is required as the particle size increases. This fact must be taken into consideration when designing cutter heads to achieve optimum SE. In general, cutter head design of a mechanical miner must be oriented in order to get the greatest penetration depth through the smallest number of cutting tools. Providing that the power, torque, and thrust are sufficient, SE leads engineers toward the most efficient cutter head designs (Rostami, Ozdemir, and Neil, 1995).

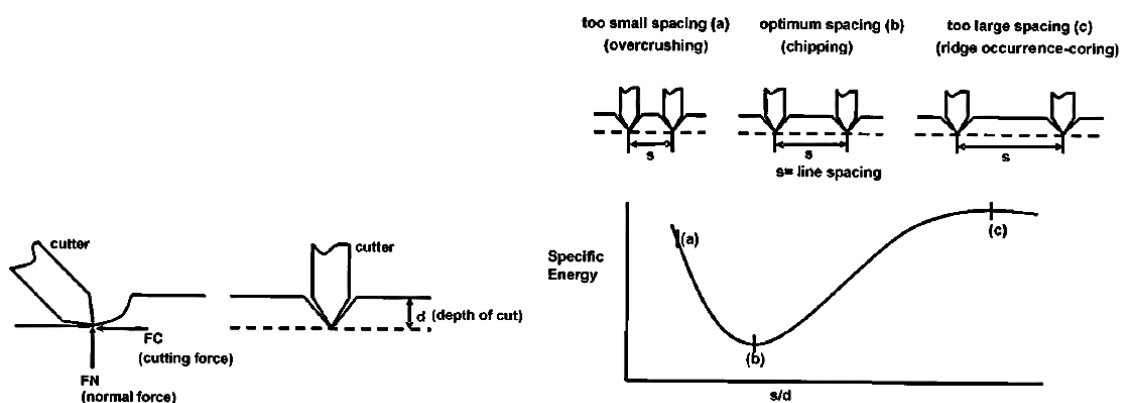
Figure 2.6. Unrelieved (left) and relieved (right) cutting modes (Çopur et al. 2001).

Three main states were introduced for relieved cutting mode, which are shown with a, b, and c in Figure 2.6 (right). In the cutting mode a, the cutter spacing is too close. This cause the rock to be overcrushed, which means that more energy is consumed to produce fine particles and dust, and the tool wear increases dramatically. In the cutting mode c, the cutter spacing is too wide that causes the cutting action to be not effective enough since the cracks generated by adjacent grooves cannot reach each other. As a result, chipping of the rock material does not occur, and the excavation process is inefficient. In the cutting mode b, which yields the most energy-efficient state, the cutters are placed in a reasonable distance from each other with respect to cutting depth. In this case, generated fragments are neither too small to waste energy nor too large to make the cutting process inefficient. Additionally, the cutter forces decrease in this mode in comparison with the unrelieved cutting mode (Çopur et al. 2001).

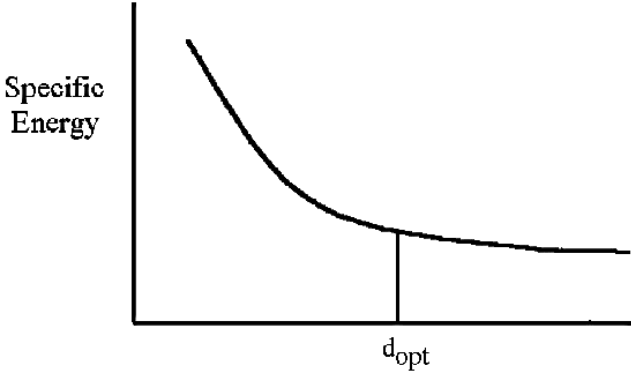
Figure 2.7. The relation between SE and cutting depth cut (Çopur et al. 2001).

Figure 2.7 depicts overall relation between the depth of cut and SE. The ideal cutting condition, in which SE is at the lowest rate, can be specified in unrelieved cutting mode. Then, the optimal depth of cut attained is used in relieved cutting mode.

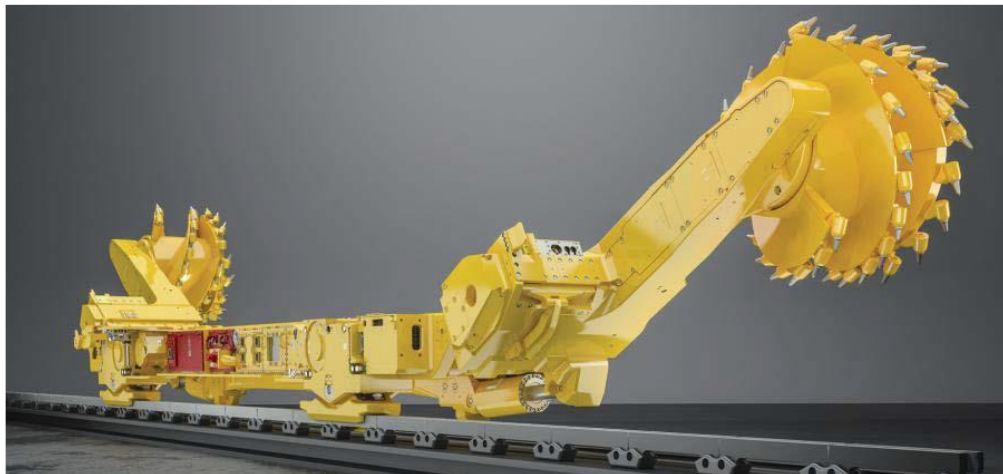
Figure 2.9. Shearer Loader (with the courtesy of Eickhoff).

Longwall mining method accounts for approximately 50% of the world's coal production, and shearers and ploughs are the main mechanical excavators used in longwall mining method (Bilgin, Copur and Balci, 2013). Shearer loaders may operate at inclinations of up to 20° and can cut coal layers ranging in thickness from 1.5 to 7.0 meters, from very weak to hard formations. The overall Machine Utilization Time of these excavators ranges from 40% to 60%. Shearers can cut coal from one end of the face or could be used bi-directionally. Figure 2.9 shows a typical shearer used in underground coal mining.

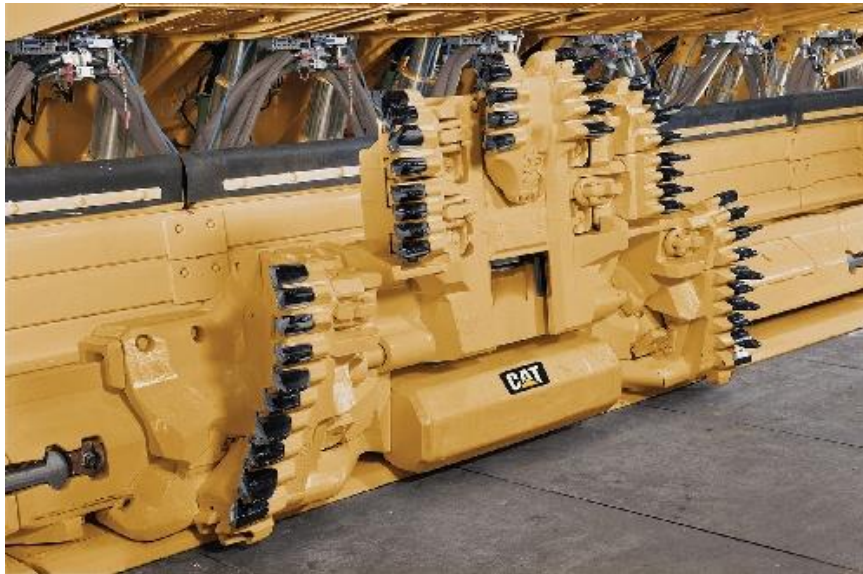
Figure 2.10. Coal plough (with the courtesy of CAT).

Coal ploughs can work in faces with a longitudinal inclination of up to 45° and are employed in medium-strength coal seams the height of which can range between 0.6 to 2.3 m. Ploughs always cut coal in both directions, and their MUT is less than shearers (Myszkowski and Paschedag, 2013). In Figure 2.10, a typical coal plough is shown. On the other hand, continuous miners are widely used machines in room-and-pillar mining, and about 45% of coal produced through this method is excavated by continuous miners (Bilgin, Copur and Balci, 2013). In room-and-pillar mining, mine is divided into a series of rooms that are 6.0-10.0 meters long and up to 30.0 meters wide. Coal seams between

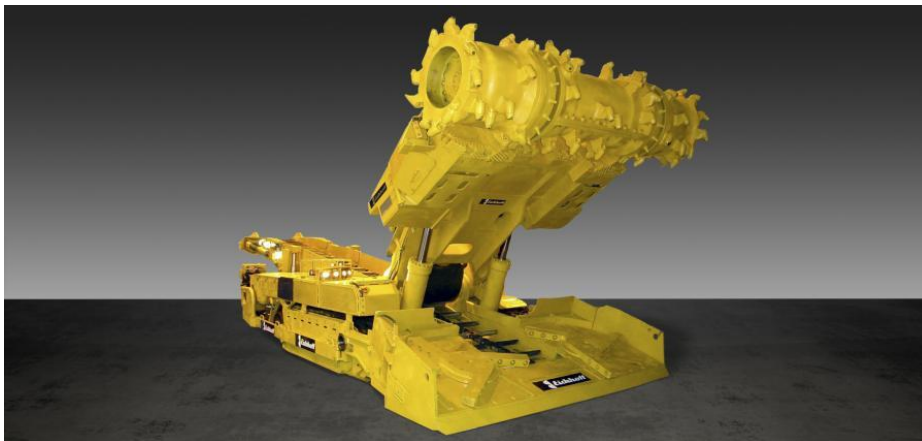
Figure 2.11. Continuous miner (with the courtesy of Eickhoff).

0.8 and 6.0 meters high can be excavated by continuous miners. A typical continuous miner is illustrated in Figure 2.11.

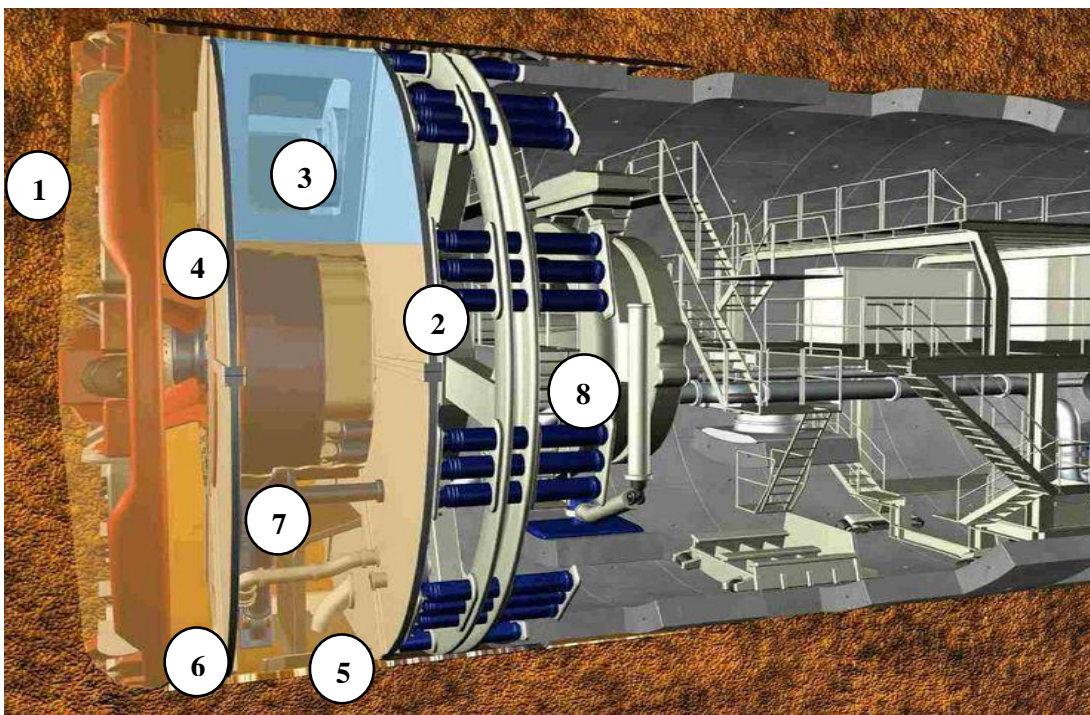
**1. Cutting wheel 2. Pressure bulkhead 3. Compressed air 4. Submerged wall 5. Slurry line 6. Stone crusher 7. Feed line 8. Segment erector**

A typical type of Slurry-TBM is depicted in Figure 2.12. In order that the excavation face can be stabilized while excavating with Slurry-TBM, pressurized bentonite slurry mixed with muck is applied on the tunnel face during the operation. Air pressure is used to adjust the necessary pressure on the tunnel face, and a hydraulic transportation system removes the mixture. Sand, gravel, and clayey/silty sand are examples of poor soil types that lack self-supporting ability and can be excavated by SPB-TBMs.

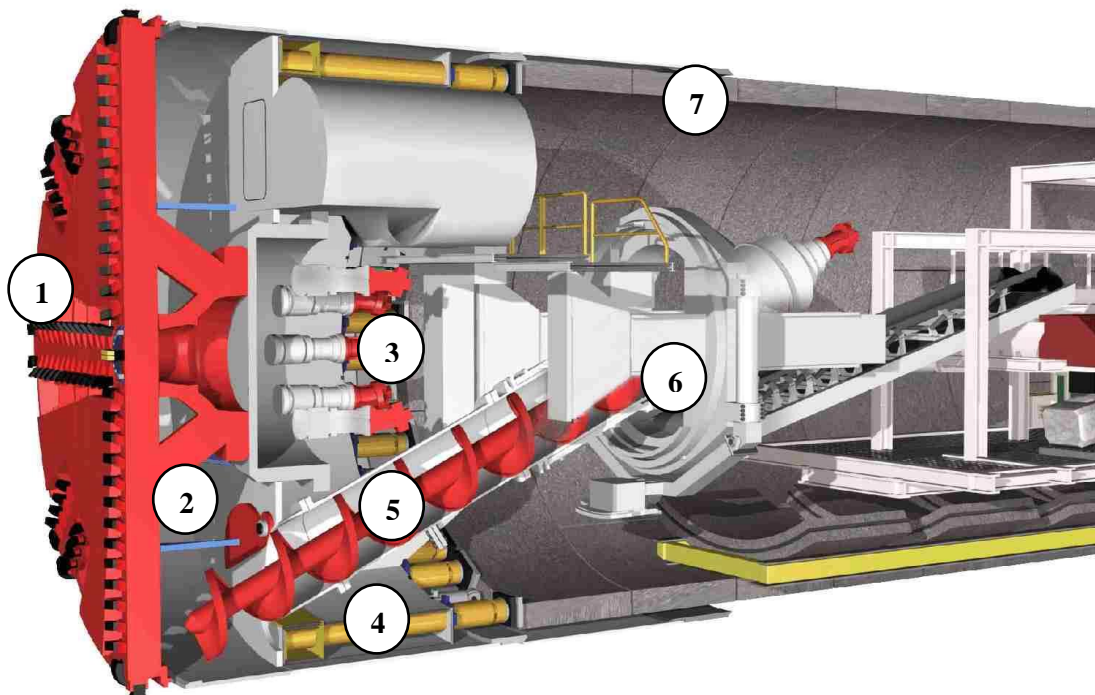
**1. Cutting wheel 2. Excavation chamber 3. Pressure bulkhead 4. Thrust cylinders 5. Screw conveyor 6. Segment erector 7. Segment lining**

Figure 2.13 illustrates various parts of an Earth Pressure Balance machine. In EPB-TBMs, hydraulic cylinders are used to pressurize the excavated soil, which enters excavation chamber, against tunnel face to balance the pressure of surrounding ground. It is obvious that in EPB-Tunneling the ground itself is the main component employed to prevent surface settlements and provides the tunnel face with required stability. However, to obtain intended condition from stability point of view and better operation, when required, the cut material in the excavation chamber can be mixed with various types of conditioning agents including foam, water, polymer, or air (Copur, 2012). To maintain a balance between the pressures applied by the machine on the excavation face and ground pressure, tunnel face pressure must be continuously controlled. To avoid stability issues on the excavation face, the screw conveyor's speed and the rate at which the excavated soil is transported must be regulated in accordance with the expected advance rate of the machine. Sand, clay, and silt are considered the soil types suitable for excavation with EPB-TBMs.

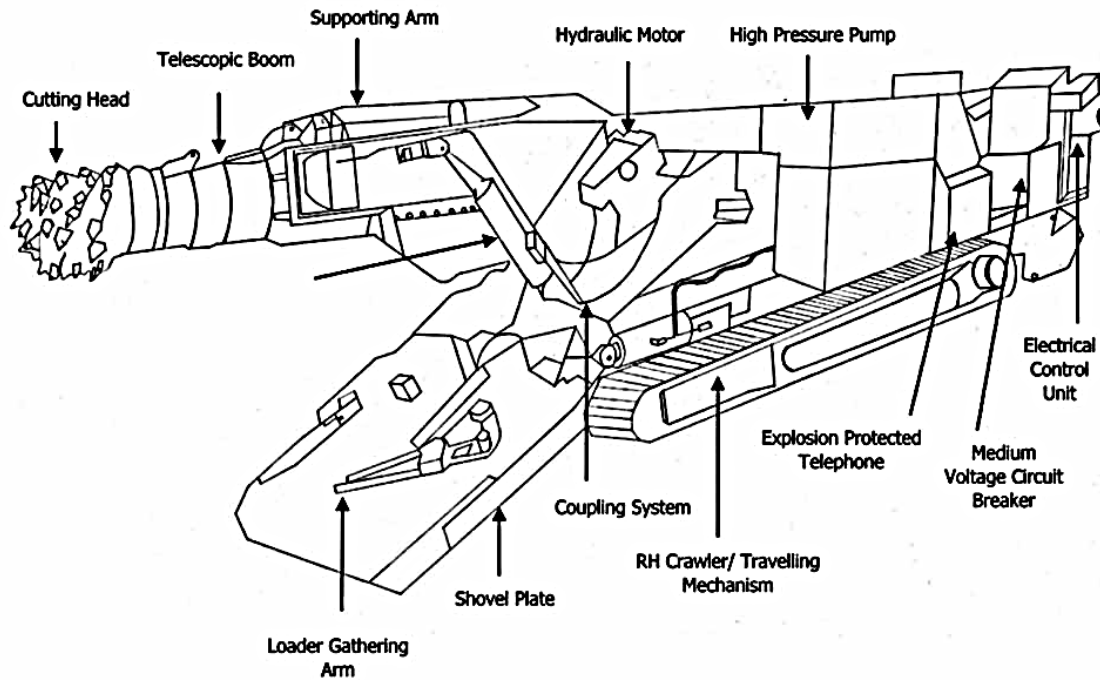
Figure 2.14. Different parts of a roadheader (with the courtesy of rotarypower).

- Cutter head and extension arm or boom
- Muck loading unit
- Travelling unit
- Dust suppression unit
- Muck transfer unit
- Hydraulic and electrical units

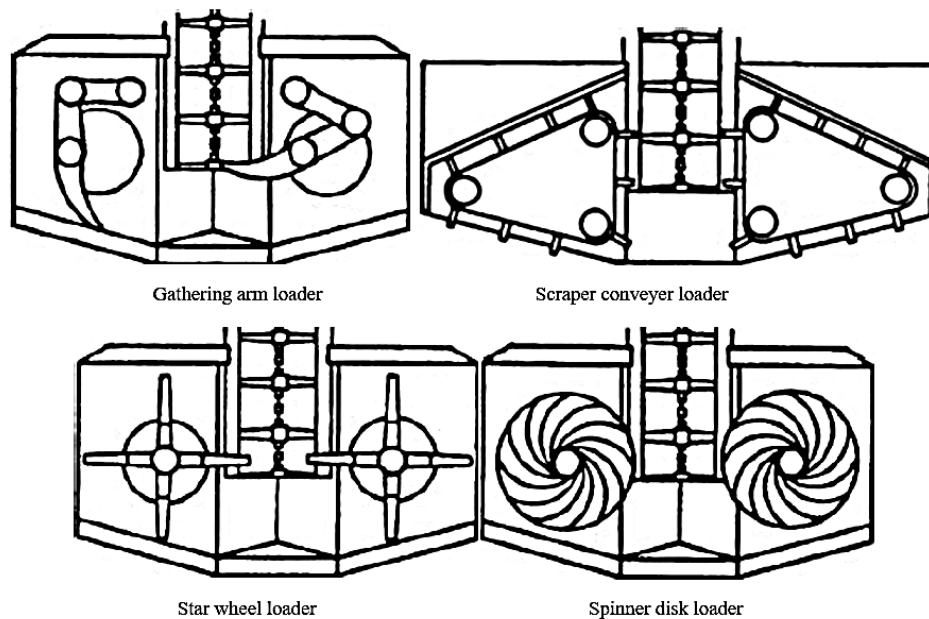
Figure 2.15. Various types of muck gathering system (Adopted from Kogelmann, 1988 as quoted by Breeds and Conway, 1992).

The muck loading unit consists of an apron and gathering components and is located in the front part of the machine. Excavated material (muck) falls onto the loading apron and is gathered and loaded into a muck transfer unit placed in the center of the loading apron. Muck gathering systems are available in four different types: gathering arm loader, star wheel loader, spinner disk loader, and scraper conveyer loader, as presented in Figure 2.15.

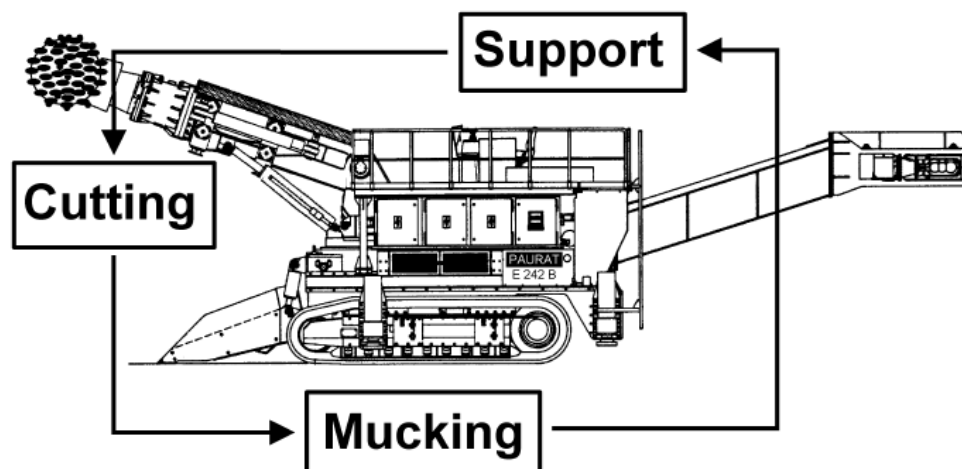
Figure 2.16. Working cycle of a Roadheader (Thuro and Plinninger 1999).

The working cycle of a roadheader is shown in Figure 2.16. It is clear that the working cycle of a roadheader consists of three main stages: cutting, mucking, and support, all of which are influenced by various parameters during the excavation. Some mechanical features of roadheaders result in certain operational conditions that are valid in nearly all situations. The conditions can be categorized as follows:

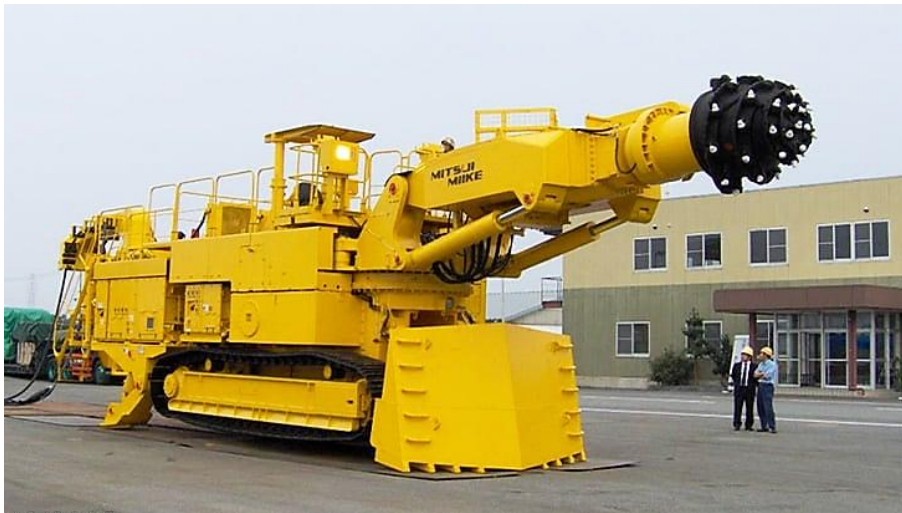
Figure 2.17. An axial type roadheader (with the courtesy of MITSUMI MIKE).

Based on the type of cutter head, roadheaders are classified into two major categories: axial type and transverse type. Figure 2.17 shows an axial type roadheader. As can be seen, in axial type roadheaders, the cutter head has an axis placed along the axis of the boom that it is placed on. These excavators are useful in excavating non-abrasive rocks with UCS of up to 60-80 MPa. Nevertheless, it is possible to excavate rocks with UCS as high as 80-100 MPa with axial type roadheaders due to structural characteristics such as bedding planes in sedimentary rocks, discontinuities, or foliations that improve the performance of roadheaders.

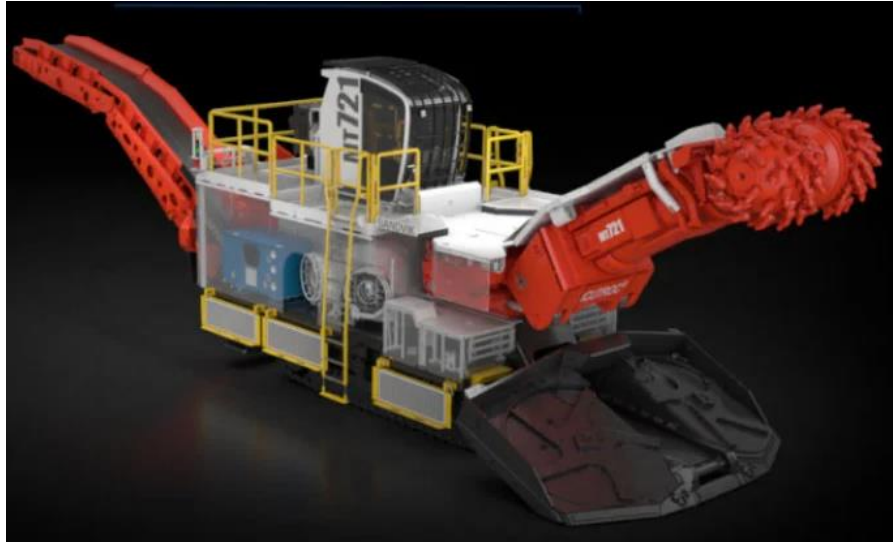
Figure 2.18. Transverse-type roadheader (with the courtesy of Sandvik).

Figure 2.18 illustrates a transverse type roadheader. As can be seen, in these excavators, there are two cutting drums, the axes of which are placed perpendicularly to the axis of the boom they are placed on. These machines are capable of performing in rocks with the UCS of up to 100-120 MPa with non- or medium-abrasivity. The forces acting on the cutter head of axial type roadheaders are transmitted to the sides of the machine, causing the roadheader to slide on the floor. If there are clay and water in roadway, this situation is exacerbated. Transverse type roadheaders bear the same forces easier than axial type roadheaders since the acting forces tend to move the machine upward, and this movement is controlled by the machine weight in most of the cases. As a result, transverse type roadheaders are more stable than axial type roadheaders (Kogelmann and Schenck, 1983). Nonetheless, axial type cutter heads generate more even and smooth excavation surfaces, whereas transverse type cutter heads develop ragged (uneven) surfaces.

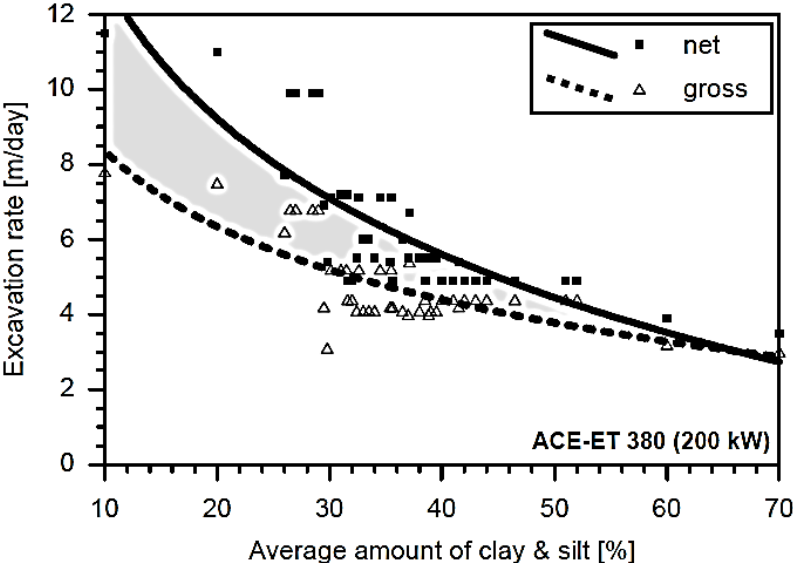
Figure 3.1. DAR of a roadheader against clay and silt percentage (Thuro and Plinninger, 1998).

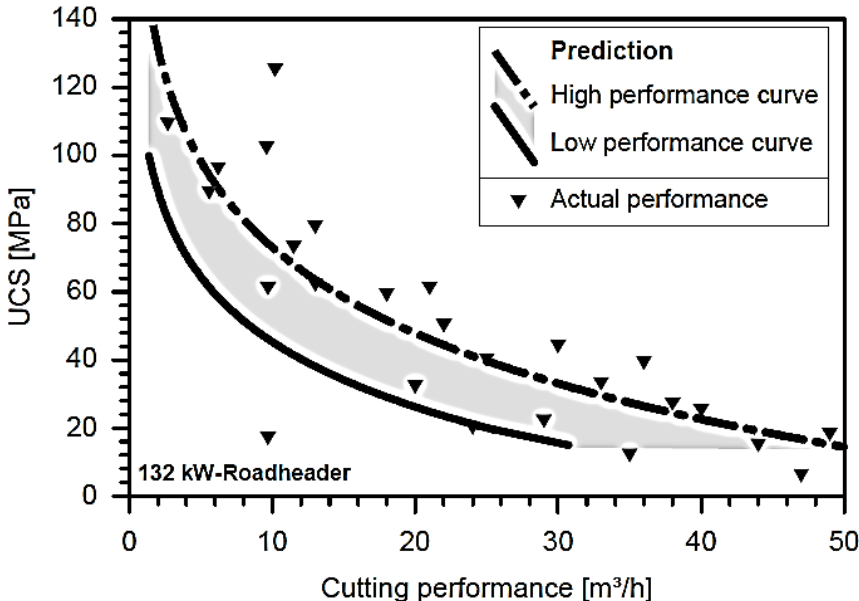
Figure 3.2. UCS versus NCR, (Thuro and Plinninger, 1999).

The effect of UCS on NCR in a sewage tunnel is illustrated in Figure 3.2. It is clear that the cutting performance is inversely affected by UCS. Two separate curves can be distinguished in this figure as high performance and low performance curves indicating the influence of joint properties on cutting performance.

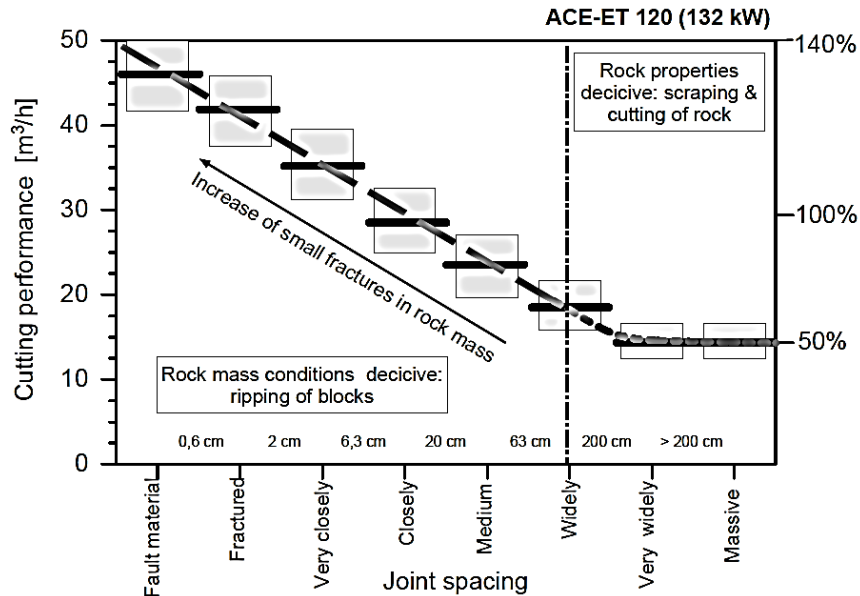
Figure 3.10. NCR of a roadheader against joint spacing (Thuro and Plininger, 1999).

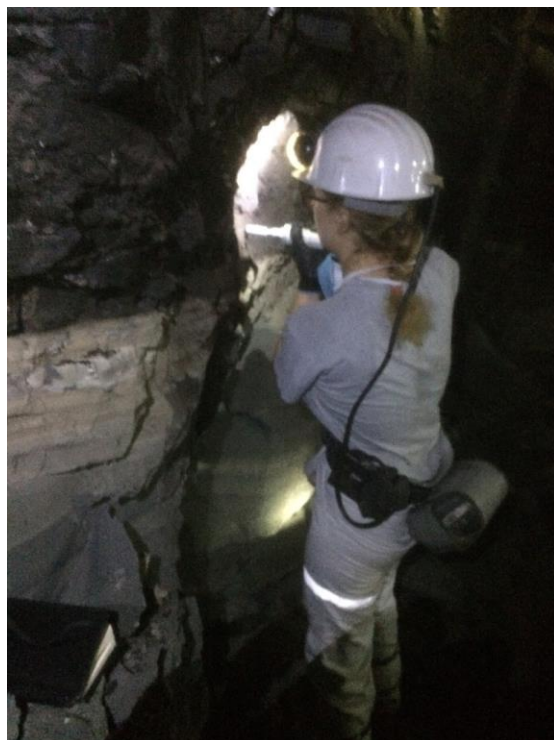
Figure 7.5. Needle penetration test.

The Needle Penetration Test conducted in Çayırhan Basin is indicated in Figure 7.5. Special attention must be paid to the measurement point. If the needle penetration causes the rock surface to break and generate radial fractures around the tip of the device, as shown in Figure 7.6, the test results must be considered invalid; similarly, when the needle penetration occurs along weakness planes, the test results must be ignored. However, if such conditions are faced during the needle withdrawal, the test is considered valid (Ulusay and Erguler, 2012).

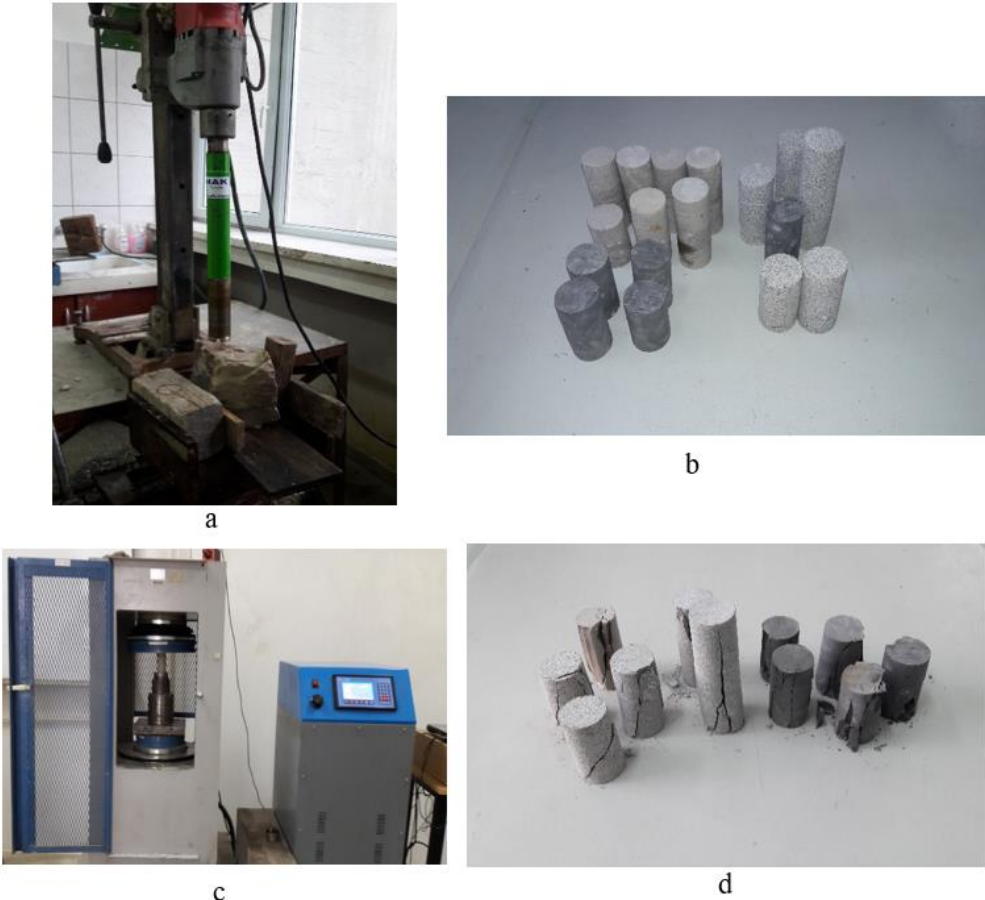
Figure 7.7. Coring machine (a), core samples (b), hydraulic press (c), and the samples after the UCS test (d).

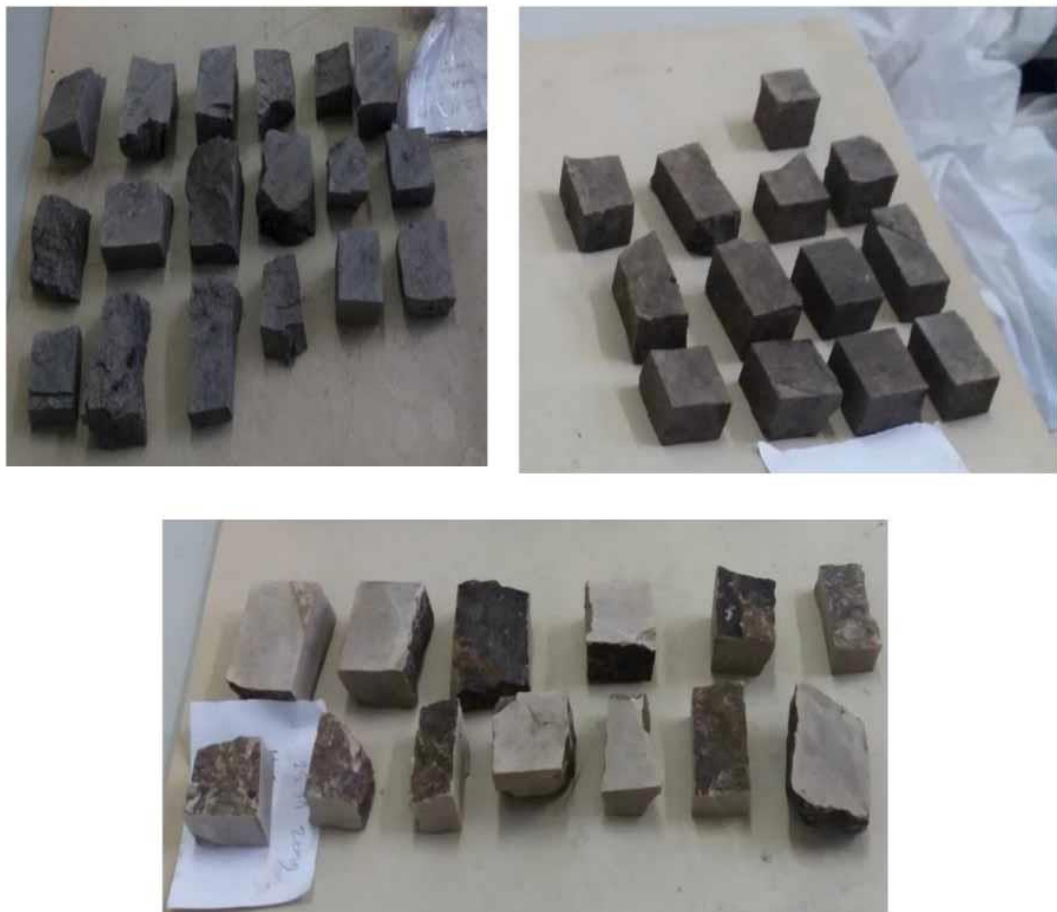
Figure 7.8. Prepared samples for point load test.

Point Load Index (PLI) tests were carried out on samples close to approximately prismatic in shape in rocks that were too hard to perform a needle penetration test and could not be cored due to discontinuities. The test was carried out in accordance with the suggested ISRM (1985) method. The tests were repeated at least twelve to thirteen times for each sample due to the high variability of the PLI results. Numerous empirical formulas are available to estimate the UCS value from the PLI. ISRM (1985) proposes to convert the PLI to the UCS value by multiplying it by 22. In the study conducted by Kahraman (2001), a value close to 22 was found between PLI and UCS for coal measure rocks. For this reason, the PLI values were multiplied by 22 and converted to the UCS values. Figure 7.8 illustrates some of the samples prepared for the Point Load Test. The UCS values obtained from the tests and estimated from the PLI values are given in Table 7.2.

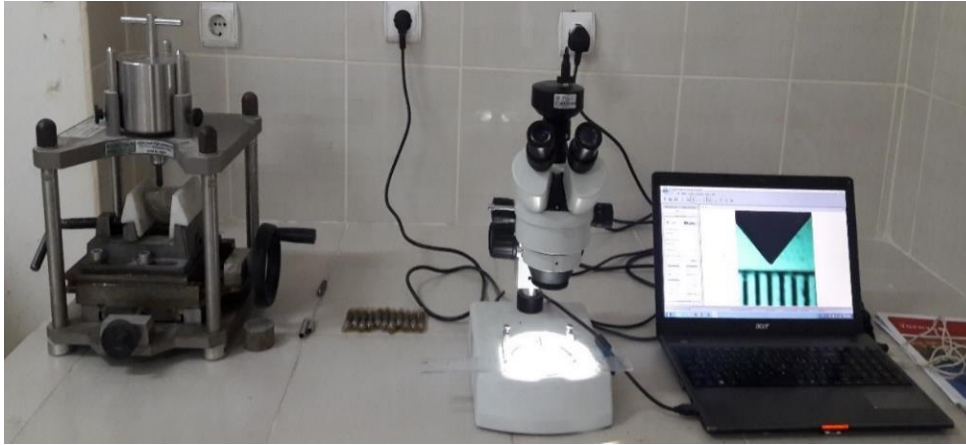
Figure 7.9. Cerchar Abrasivity Test setup.

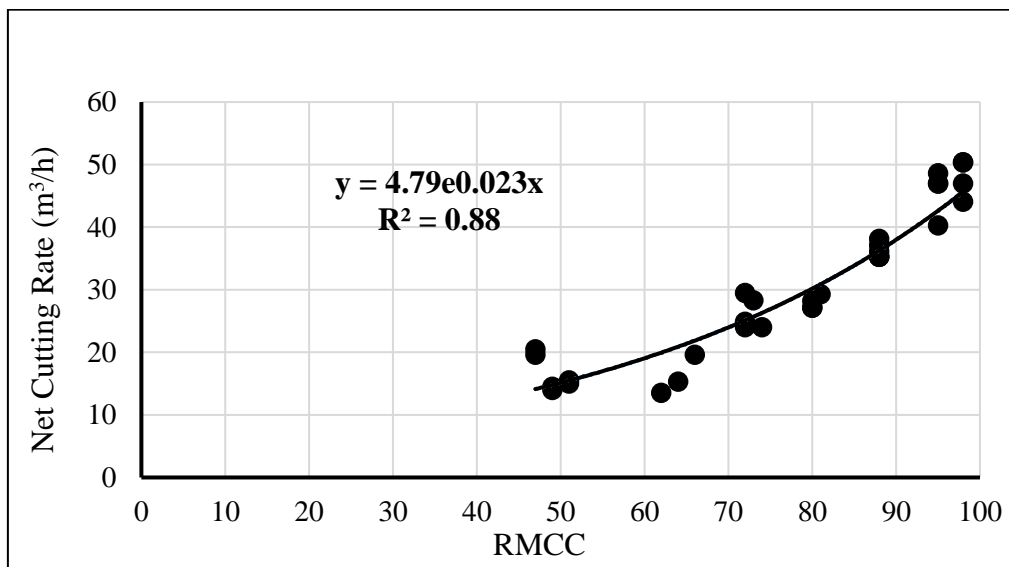
Figure 8.1. NCR versus RMCC index for 112kW axial roadheaders.

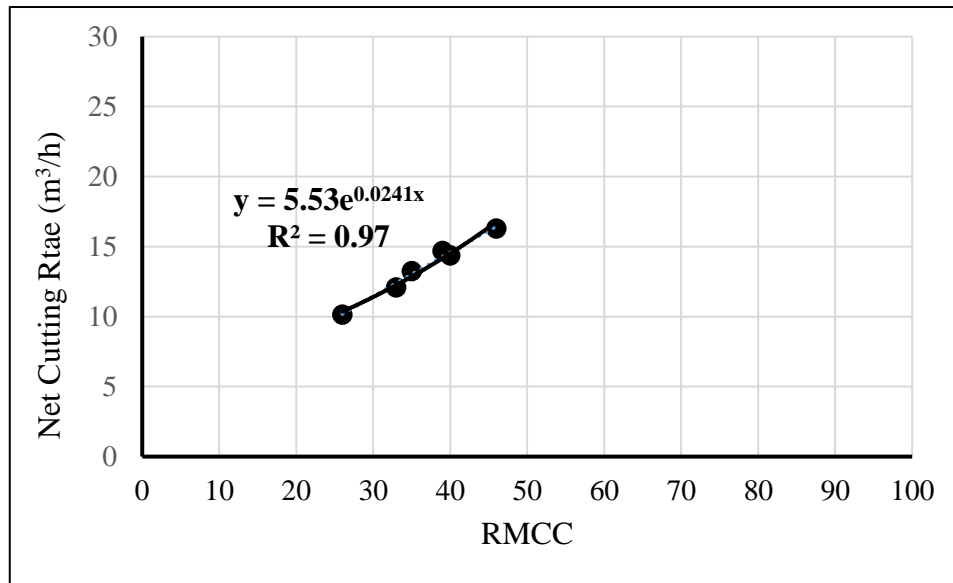
Figure 8.2. NCR against and RMCC index for 160kW axial type roadheaders.

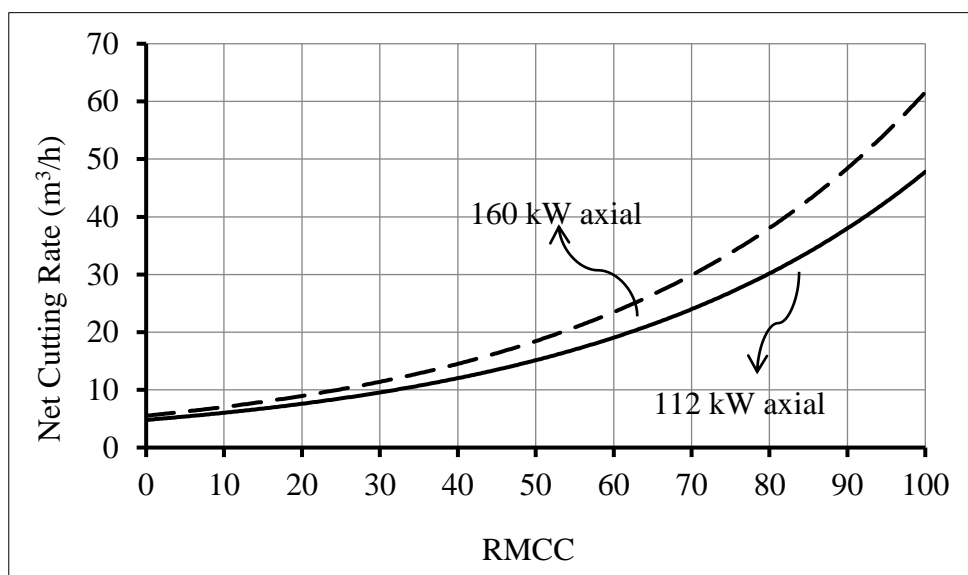
Figure 8.3. Comparison of NCR and RMCC index relations of 112 kW and 160 kW axial type roadheaders.

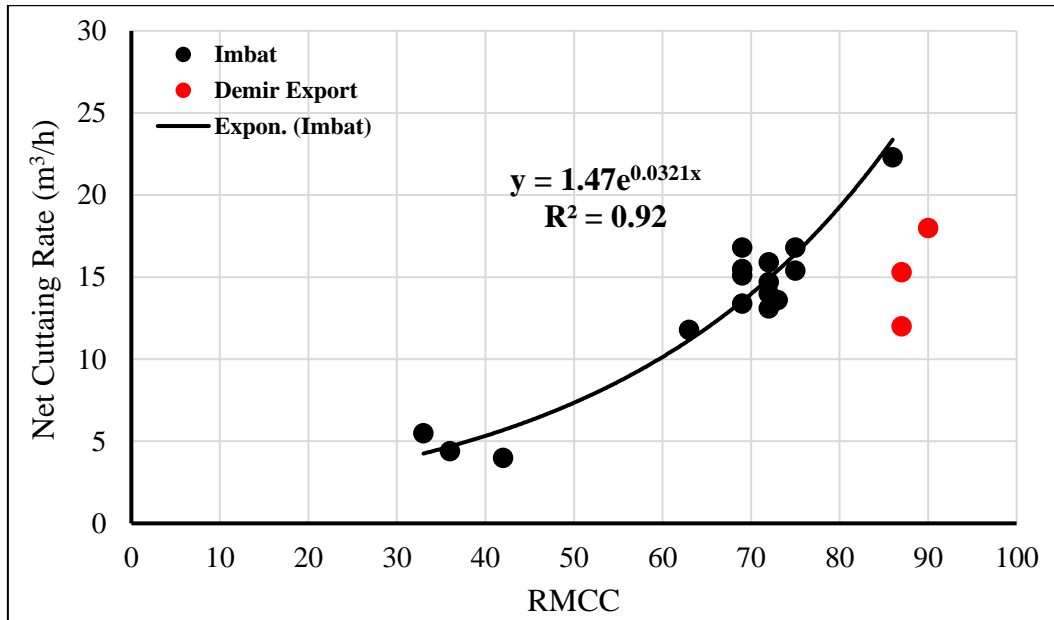
Figure 8.4. NCR against RMCC index for 100 kW transverse type roadheaders (Data marked in red show the outliers).

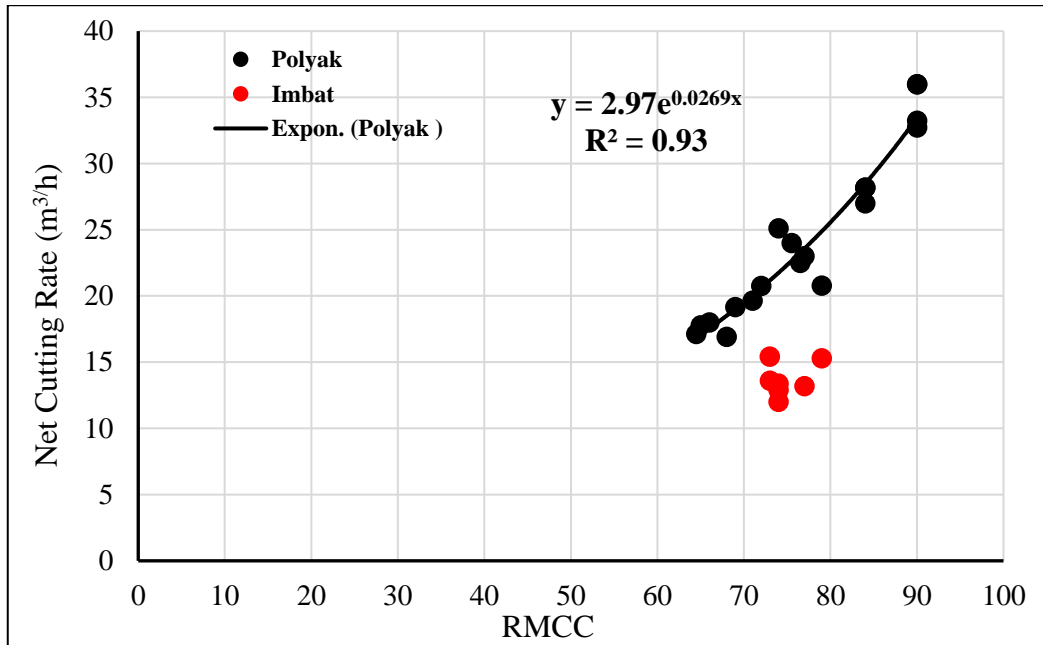
Figure 8.5. Relationship between NCR and RMCC index for 132 kW transverse type roadheader (Data marked in red show the outliers).

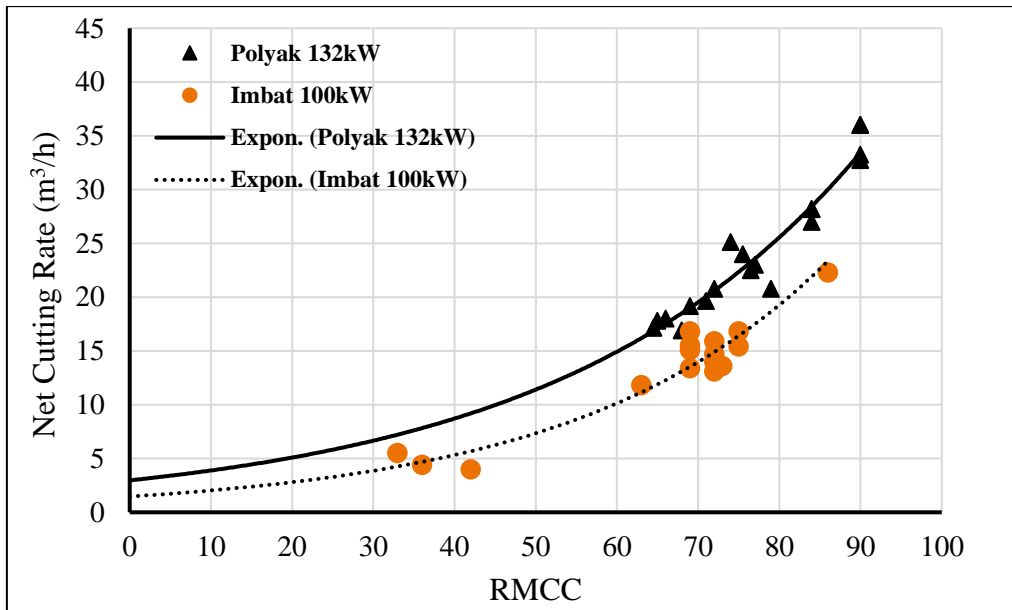
Figure 8.6. Comparison of NCR and RMCC index relations of 100 kW and 132 kW transverses type roadheaders.
