**A GENERAL EVALUATION OF THE PERFORMANCE  
OF ROADHEADERS USED IN COAL MINES**

**Behnaz HALLAJI DİBAVAR**

Submitted to  
Graduate School of Science and Engineering of Hacettepe University as a Partial  
Fulfillment to the Requirements for the Award of the Degree of Doctor of Philosophy in  
Mining Engineering.

2023

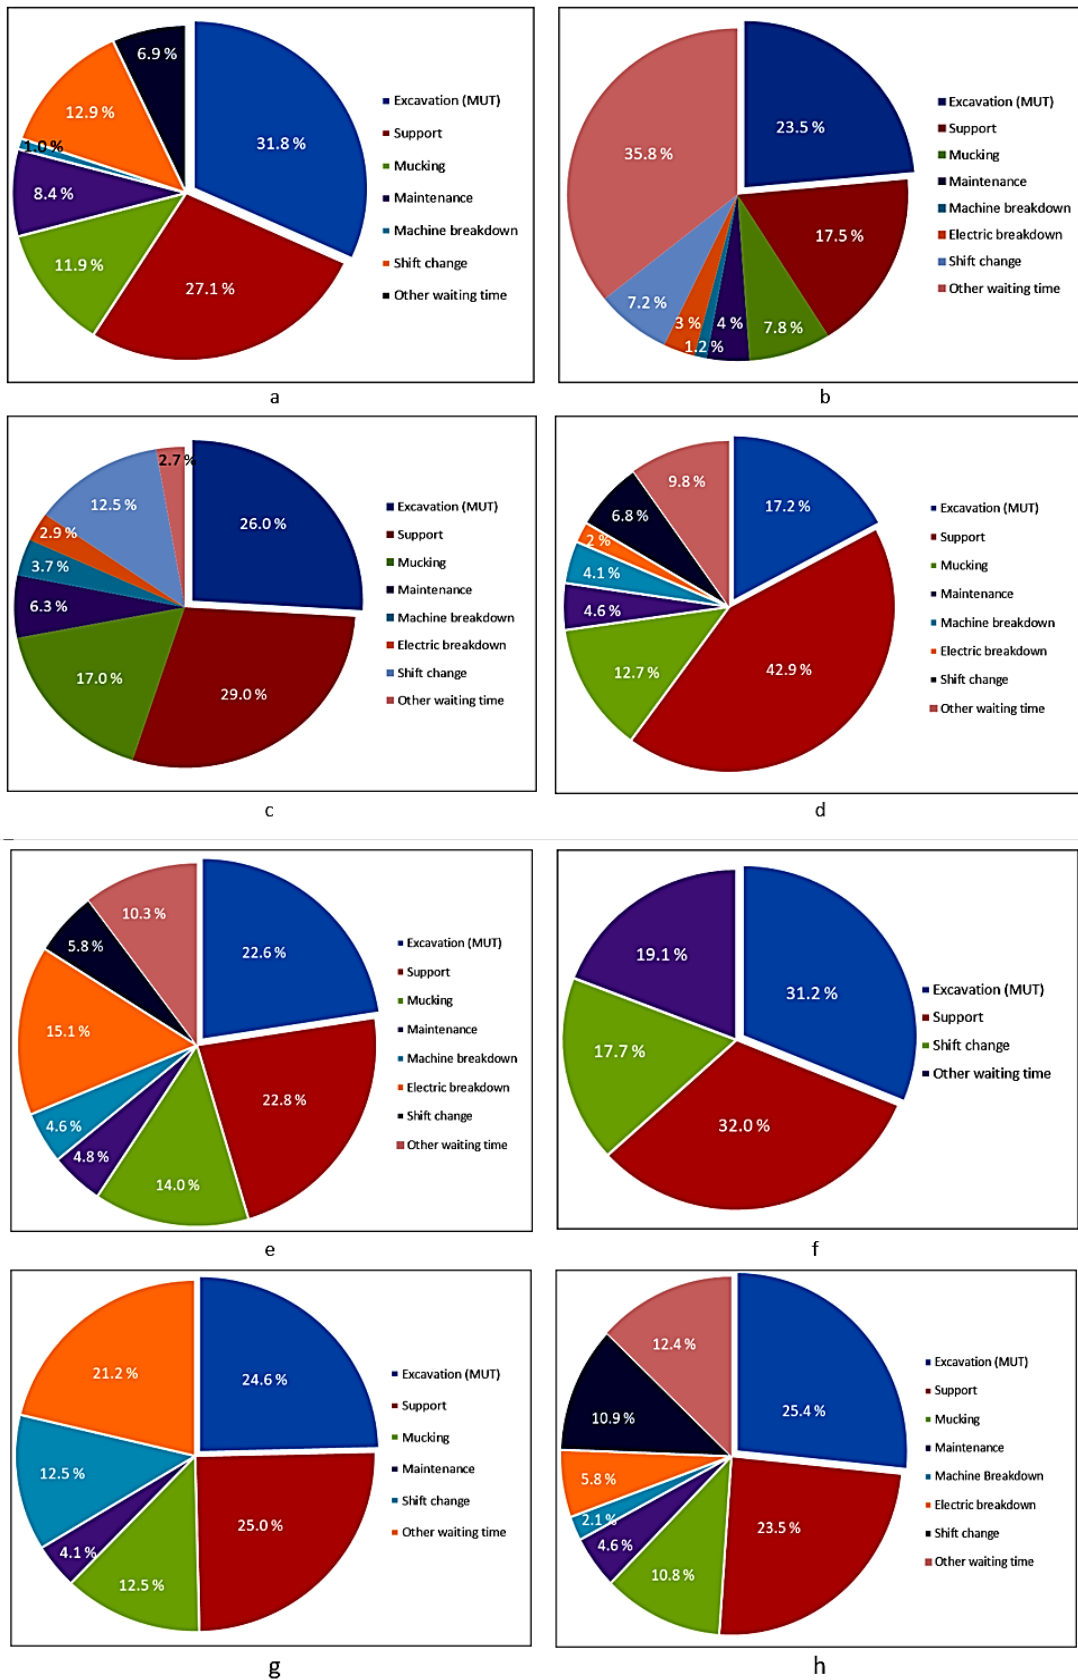
Figure 10.1. The overall performances of roadheaders for coal mine A (a), coal mine B (b), coal mine C (c), coal mine D (d), coal mine E (e), coal mine F (f), coal mine G (g), and all coal mines (h).
