THE BEHAVIOUR OF STRUCTURES BUILT ON ACTIVE FAULT ZONES : EXAMPLES FROM THE RECENT EARTHQUAKES OF TURKEY

Reşat ULUSAY¹, Ömer AYDAN² and Masanori HAMADA³

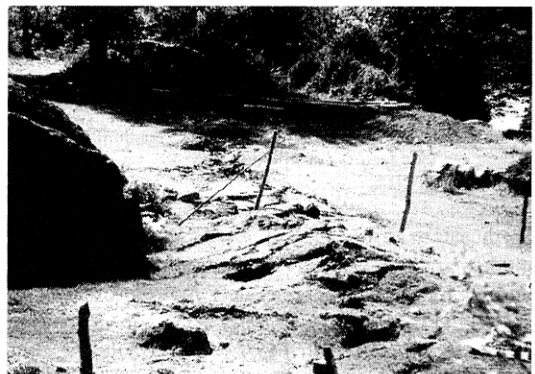
Fig.4 Moletrack between Gölyaka and Akyazi in Aksudere valley (Kocaeli Earthquake).

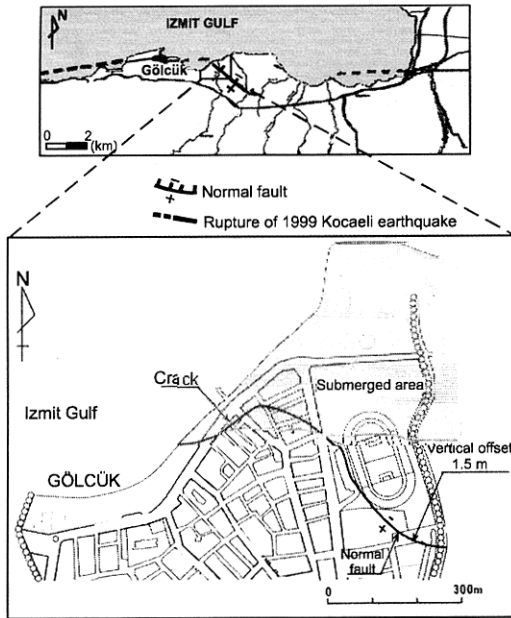
In the western part of the earthquake-affected region, between Kavaklı (Gölcük) and Hisareyn, a normal fault striking N45-60W/75-80NE with a significant vertical offset was observed. It produced a scarp of 3.5 km in total length and a vertical movement or a drop up to 2 m and some lateral movement (Fig.5). The fault initiates somewhere at the sea shore in Kavaklı and terminates near the D-80 highway in Hisareyn village without apparent connection

Fig.5 (a) Location and orientation of the normal fault at the east of Gölcük, and (b) a part of submerged land in Gölcük town (rearranged from Ishihara et al. 2000⁴⁾).

northeastern part of Gölcük town (see **Fig.5**). Several models are suggested for explaining the cause of the normal faulting. These models may be broadly divided into the pull-apart model and the fracture zone model as illustrated in **Fig.7**. To validate the pull-apart model one need to find one more lateral strike-slip fault segment at the Hisareyn terminus of the normal fault. Since such a fault could not be found during both aerial and land surveying of this normal fault, this model must be declined.

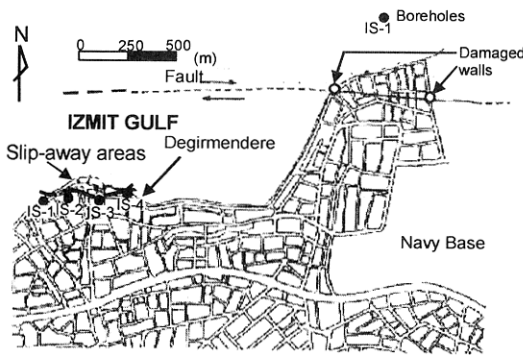
Fig.25 Locations of fault break, land submerged and geotechnical boreholes drilled after the Kocaeli earthquake (rearranged from Ishihara et al. 2000⁴⁾, and Kiper and Arel 2000¹¹⁾).

liquefaction has also some roles in submarine slides. The most publicised submarine slide took place at Degirmendere where a 5-story hotel slid into the sea together with two adjacent buildings (Fig.24). The site investigations showed that there were tension cracks extending into the land at a distance of 75–80 m from the post failure seashore. The spacing of these tension cracks was quite consistent. The coastal land about 250 m long was chopped away into the sea (Fig.25).

(see Fig.3a), and the fault break disappears near the shore between Gölciik and Değirmendere. Based on the general trend of the fault break at this locality, it is possible to consider that the fault break passes very close to Degirmendere coastline under the sea as illustrated in Fig.25. As previously stated in the previous investigations^{4),11)}, it seems that the most important factor contributed to this ground failure occurred in the form of submarine landslide is the disturbance effect in the fault zone.

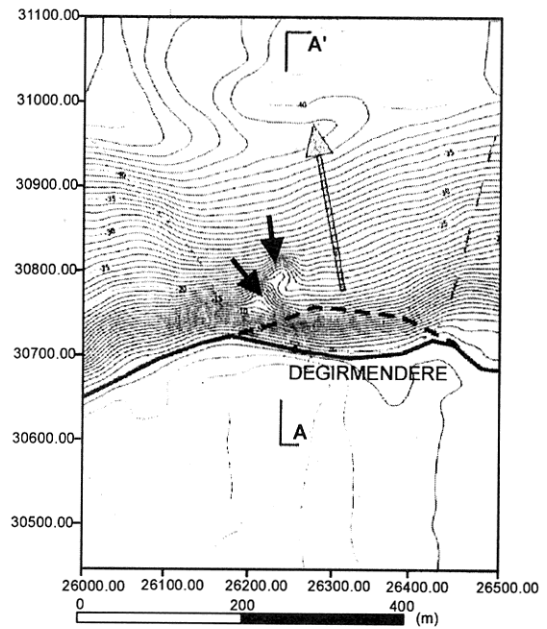
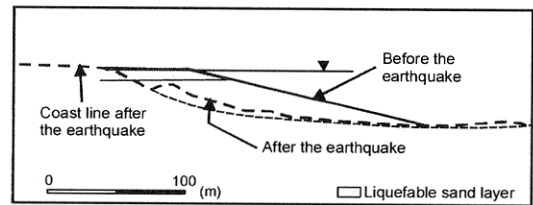
Fig.26 (a) Bathymetry of Degirmendere coast and vicinity, and (b) configuration of the seabed before and after the Kocaeli earthquake (rearranged from Kiper and Arel 2000¹¹⁾, and Ishihara et al. 2000⁴⁾).

After the Kocaeli earthquake, depth of water was measured⁴⁾ and the bathymetry map of the seabed in the vicinity of Degirmendere was prepared¹¹⁾. From Fig.26 it is evident that the seabed topography considerably changed after the earthquake. Abrupt changes in the configurations of contour lines at northwest of the sliding land (shown by dashed arrows in Fig.26a) and heaves at the bottom of the sea (Fig.26b) probably suggest that the sliding material spreaded about 300–350 m from the shoreline. The right-lateral offset reaches to a maximum value (4.5 m) in this area

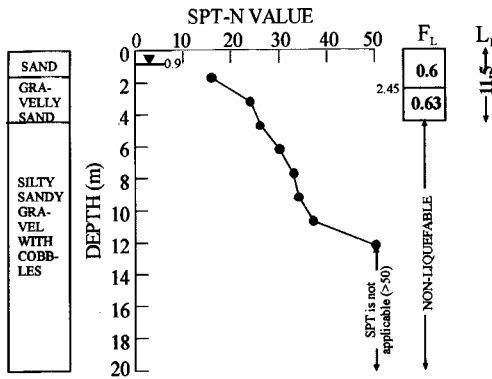
BOREHOLE: IS-1

Fig.27 Simplified borehole logs illustrating ground conditions, variation of SPT-N values with depth and liquefiable layers at Degirmendere coast line (F_L : Factor of safety against liquefaction, L_1 : Liquefaction potential index, N.L.: Non-liquefiable).

An attempt was made by the authors to assess the effect of liquefaction on this failure as a supplementary work to the previous observations. For the purpose, data (Fig.27) from four geotechnical boreholes of 20 m deep drilled after the earthquake near the slip-away coast line of Degirmendere by a private firm (see Fig.25) were employed. Fig.27 suggests a very shallow groundwater table and fully saturated soils. At the top, except fill materials 1 to 1.5 m thick, there are generally silty sand (SM) layers of 3 to 7 m thick above moderately dense silty sandy gravels (GW-GM). The method based on the
