IMAGE SECTION

Mass-like appearance of a saphenous vein graft

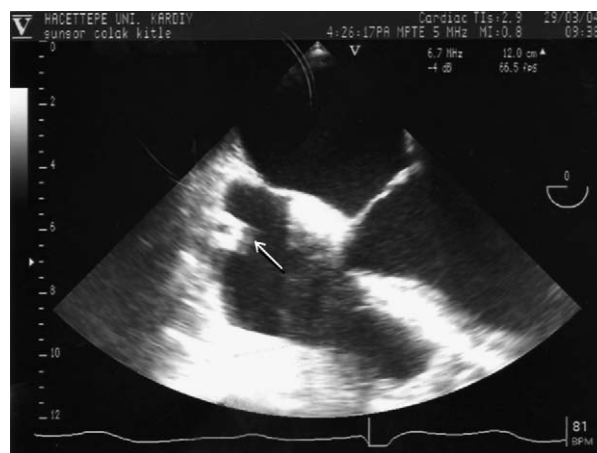
Figure 1 Saphenous vein graft to the right coronary artery on transesophageal echocardiography.

A 64-year-old man with a history of ischaemic heart disease and hypertension underwent coronary artery by-pass grafting operation in 1997 after an attack of inferior myocardial infarction. At his last visit a normal physical examination was noted along with an unchanged ECG. On transthoracic echocardiography, a mass-like structure was noted on the free wall of the right atrium. The mass could not be identified due to imaging quality, thus a transesophageal echocardiography was scheduled to rule out a pathologic mass. On transesophageal echocardiography, it was noted that the structure was a round cystic mass like a vessel and it was thought that it may be a saphenous vein graft to right coronary artery (Fig. 1, arrow). Cardiac MRI and MR angiography confirmed the diagnosis. This case highlights the importance of
